PROJECT BRIEF

Historic District Board of Review Application for Certificate of Appropriateness at 502 E. Second St. to replace front door and deteriorated window frames on the front first floor elevation.

HDCA-23-45

Certificate of Appropriateness (COA) Application

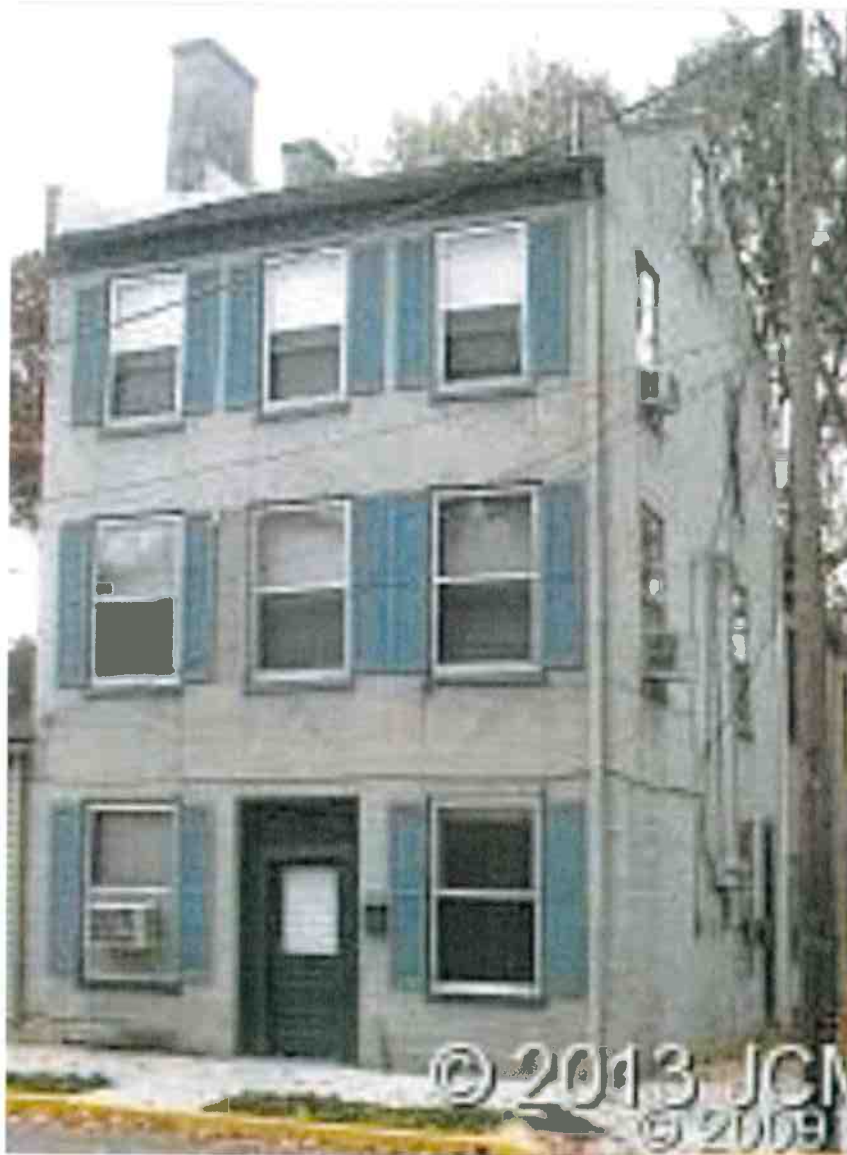
502 e second 1.PNG

Replace broken and rotted front door with a secure front door, replace rotted window frames that had plexiglass with locking glass windows.

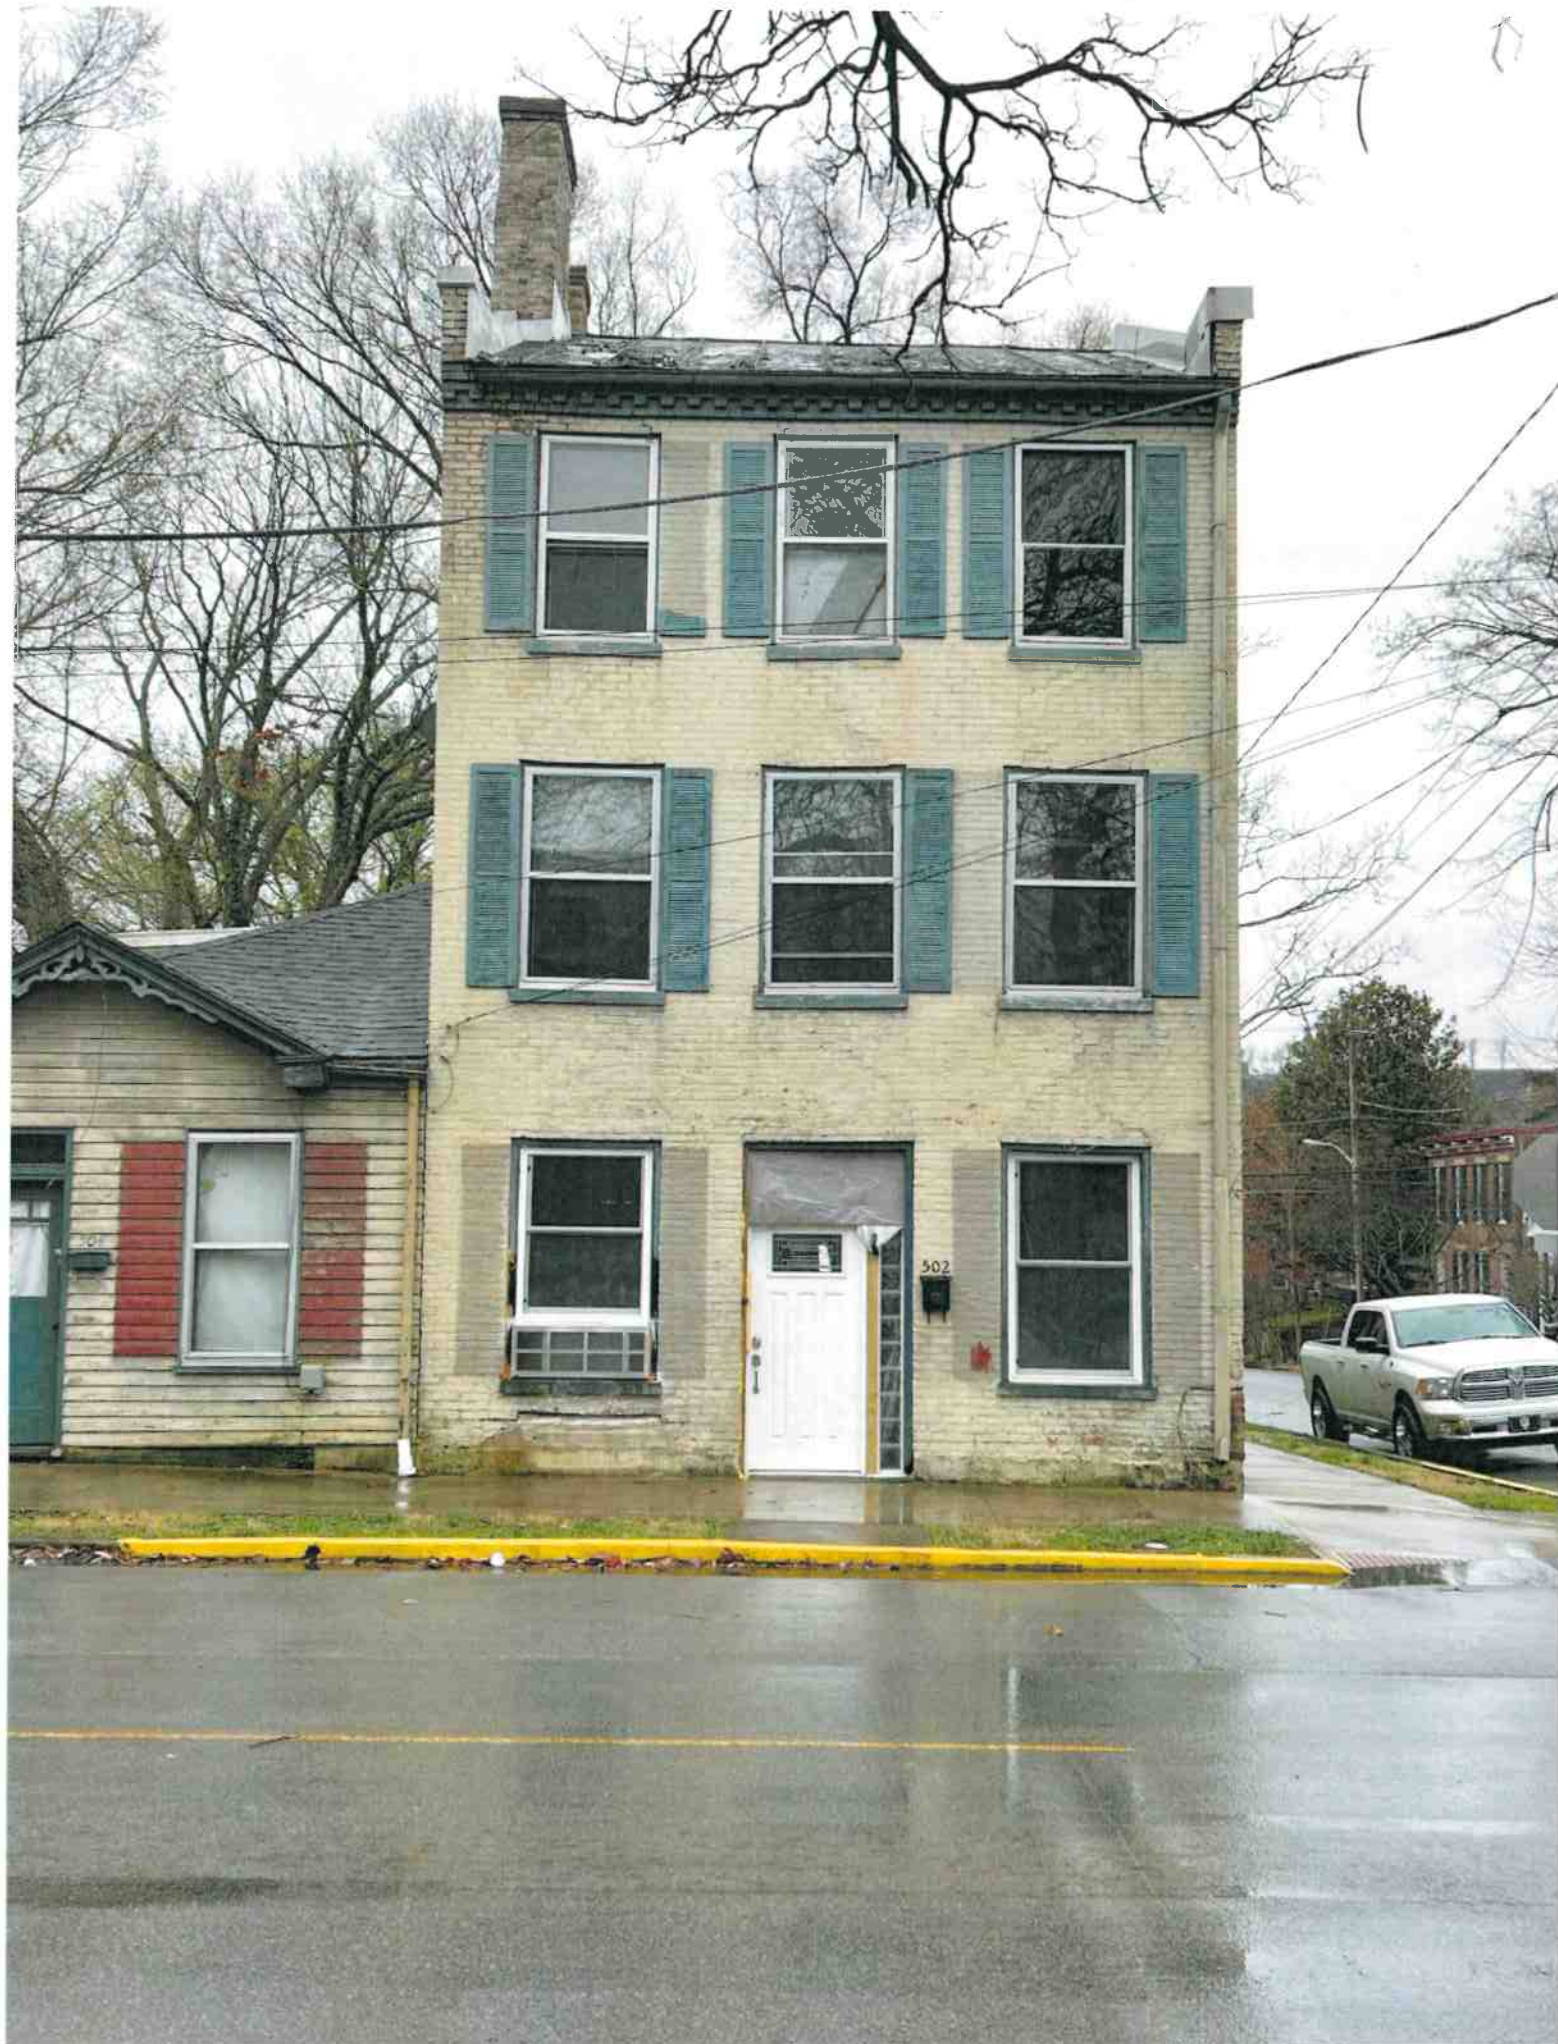
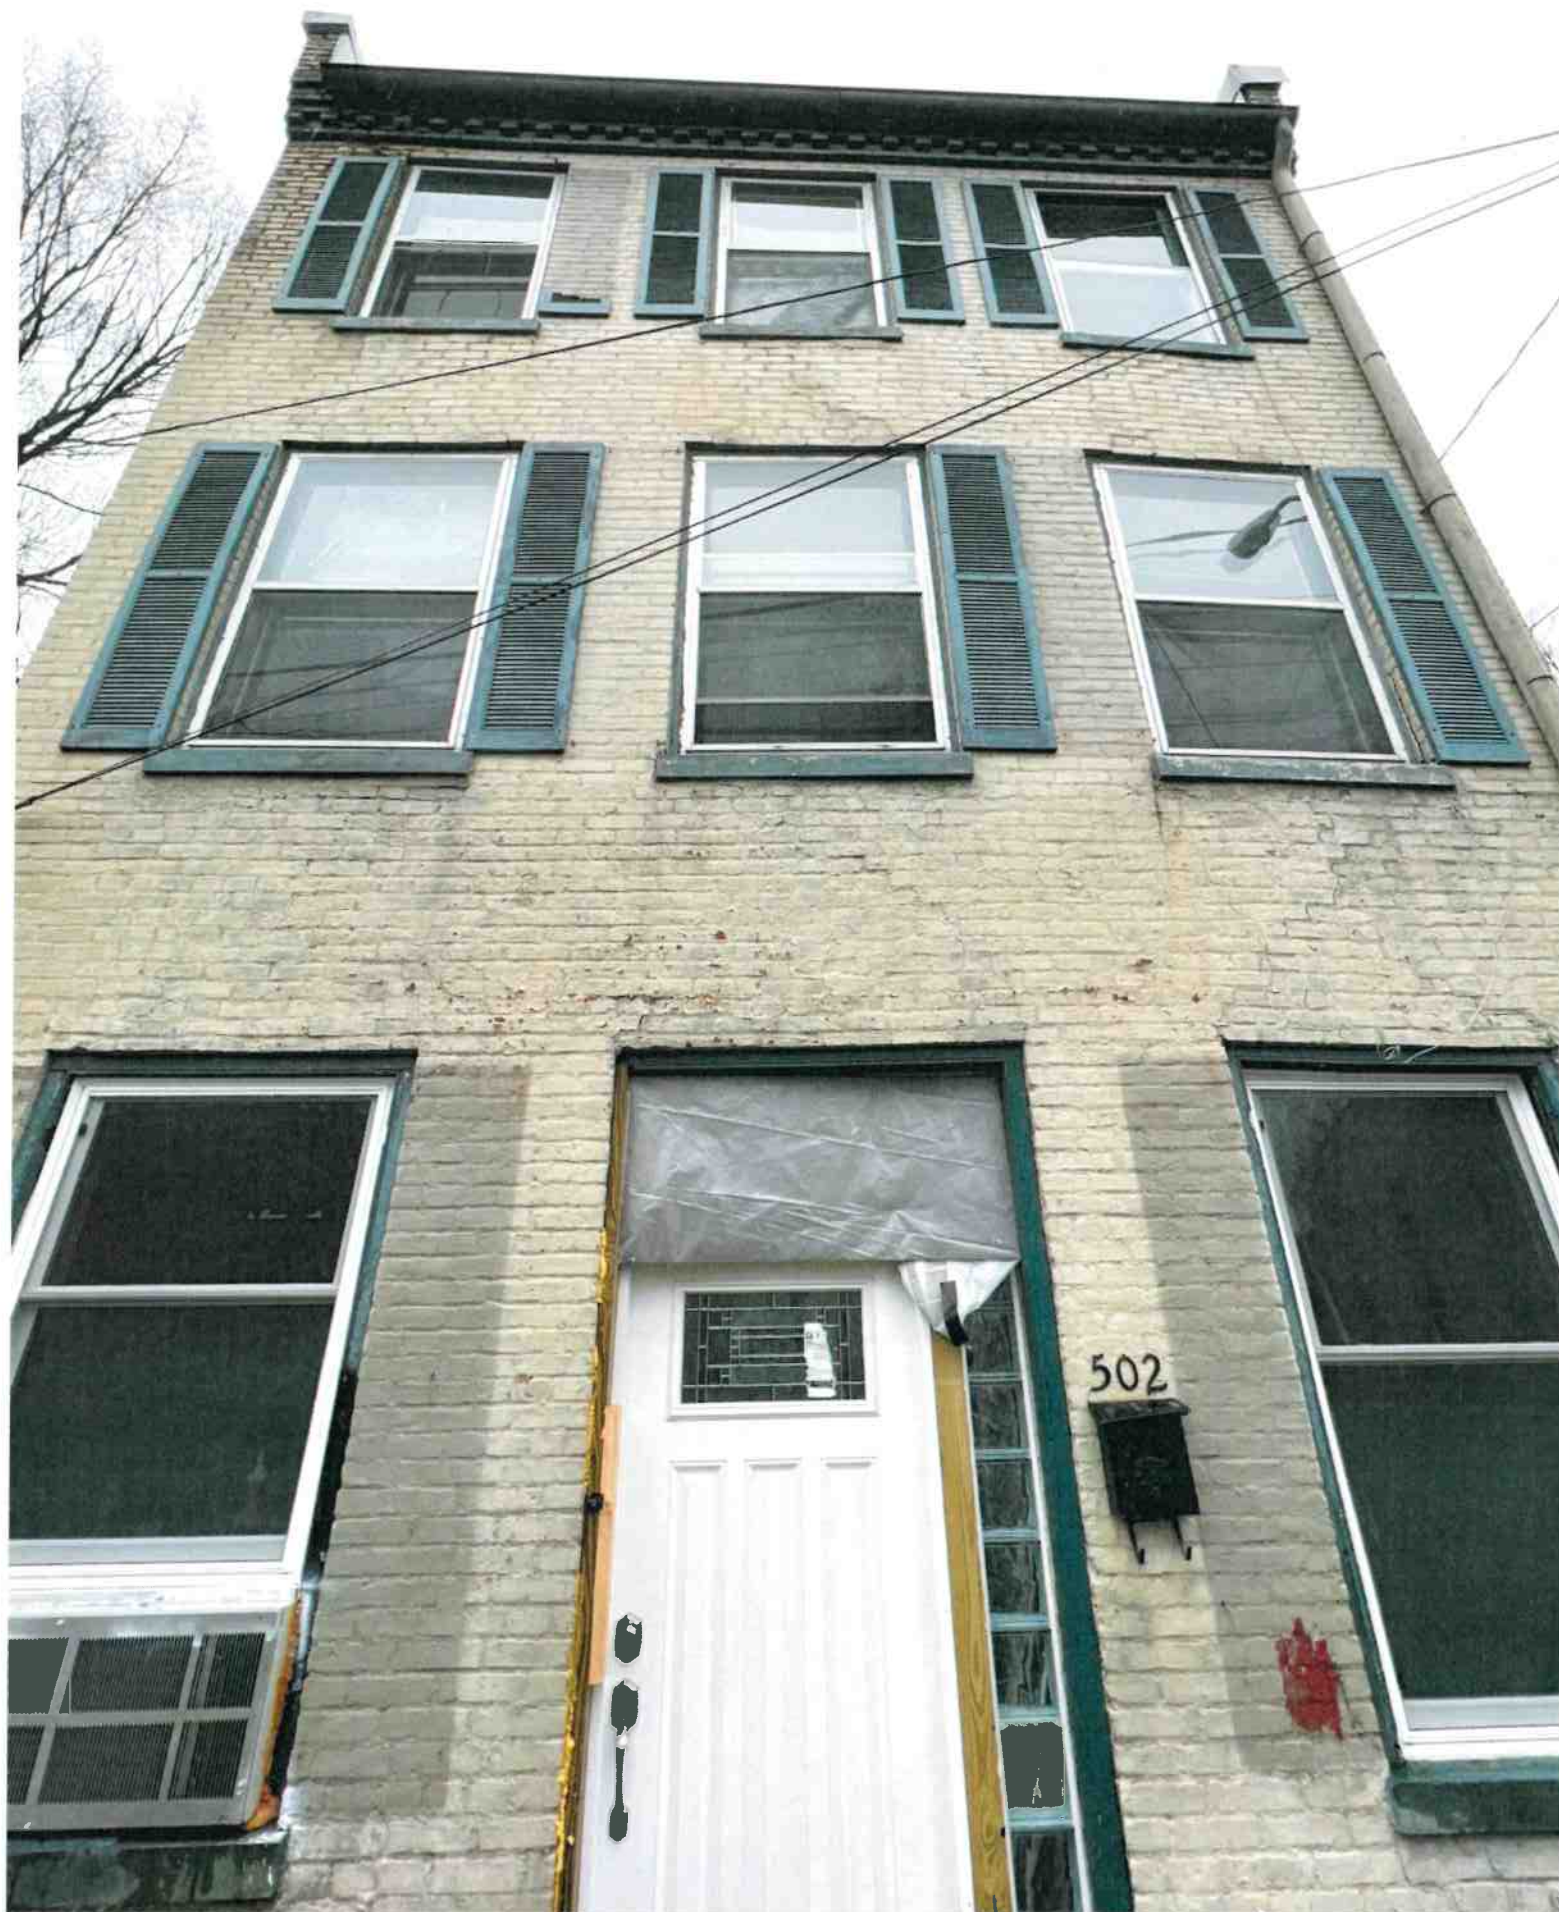
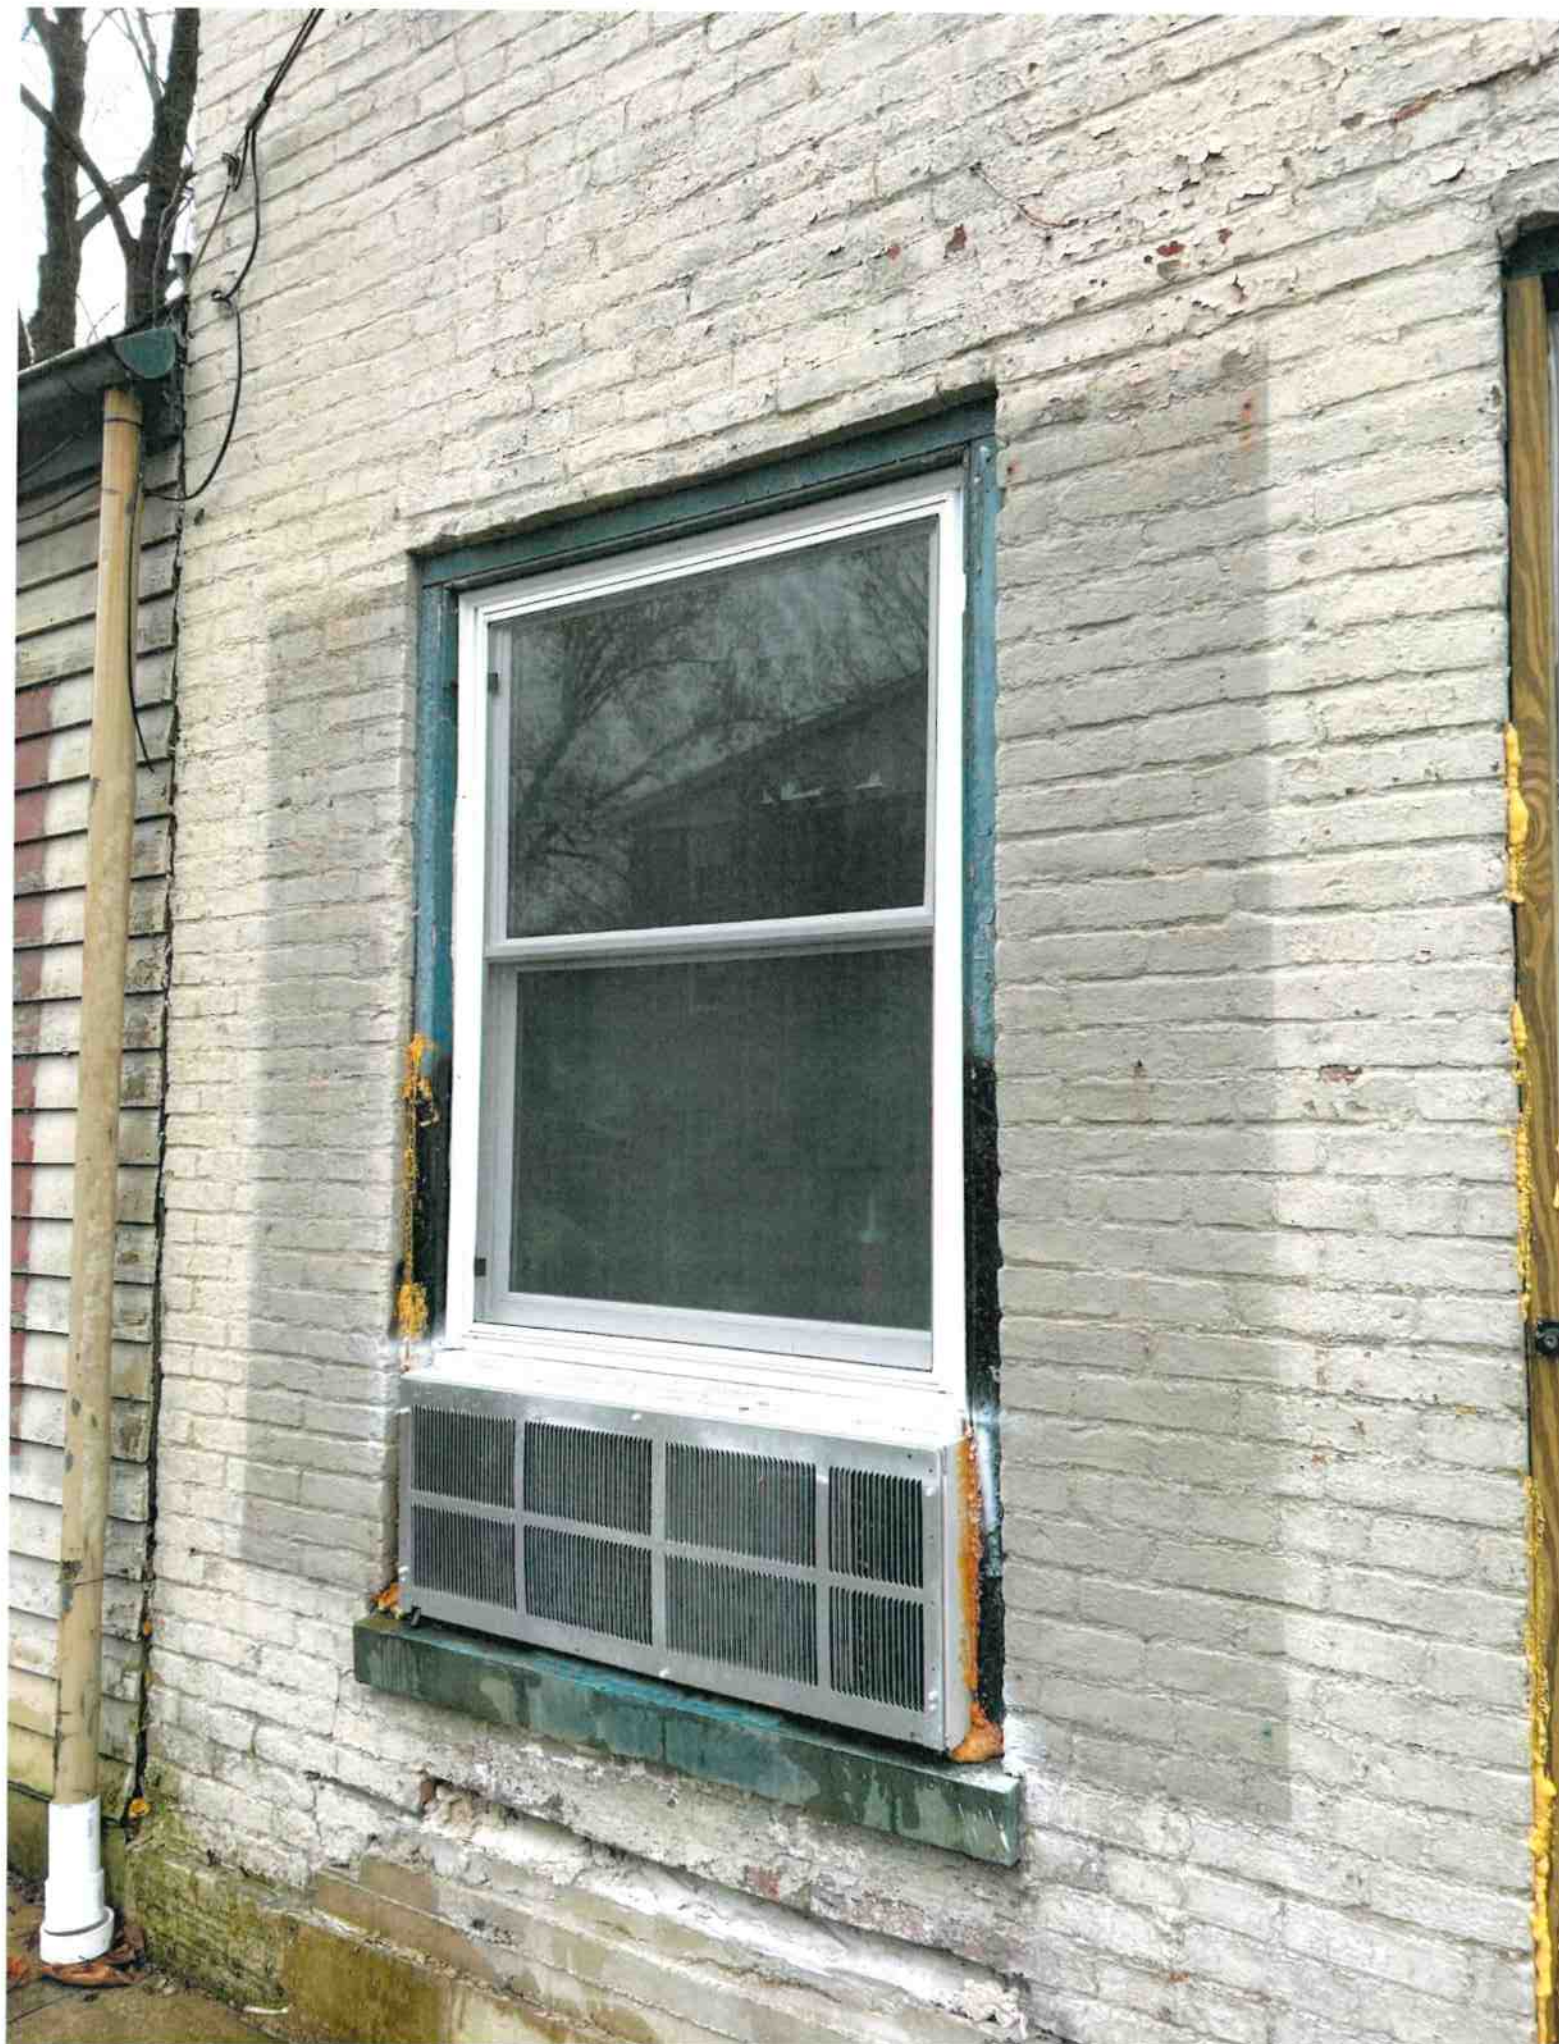
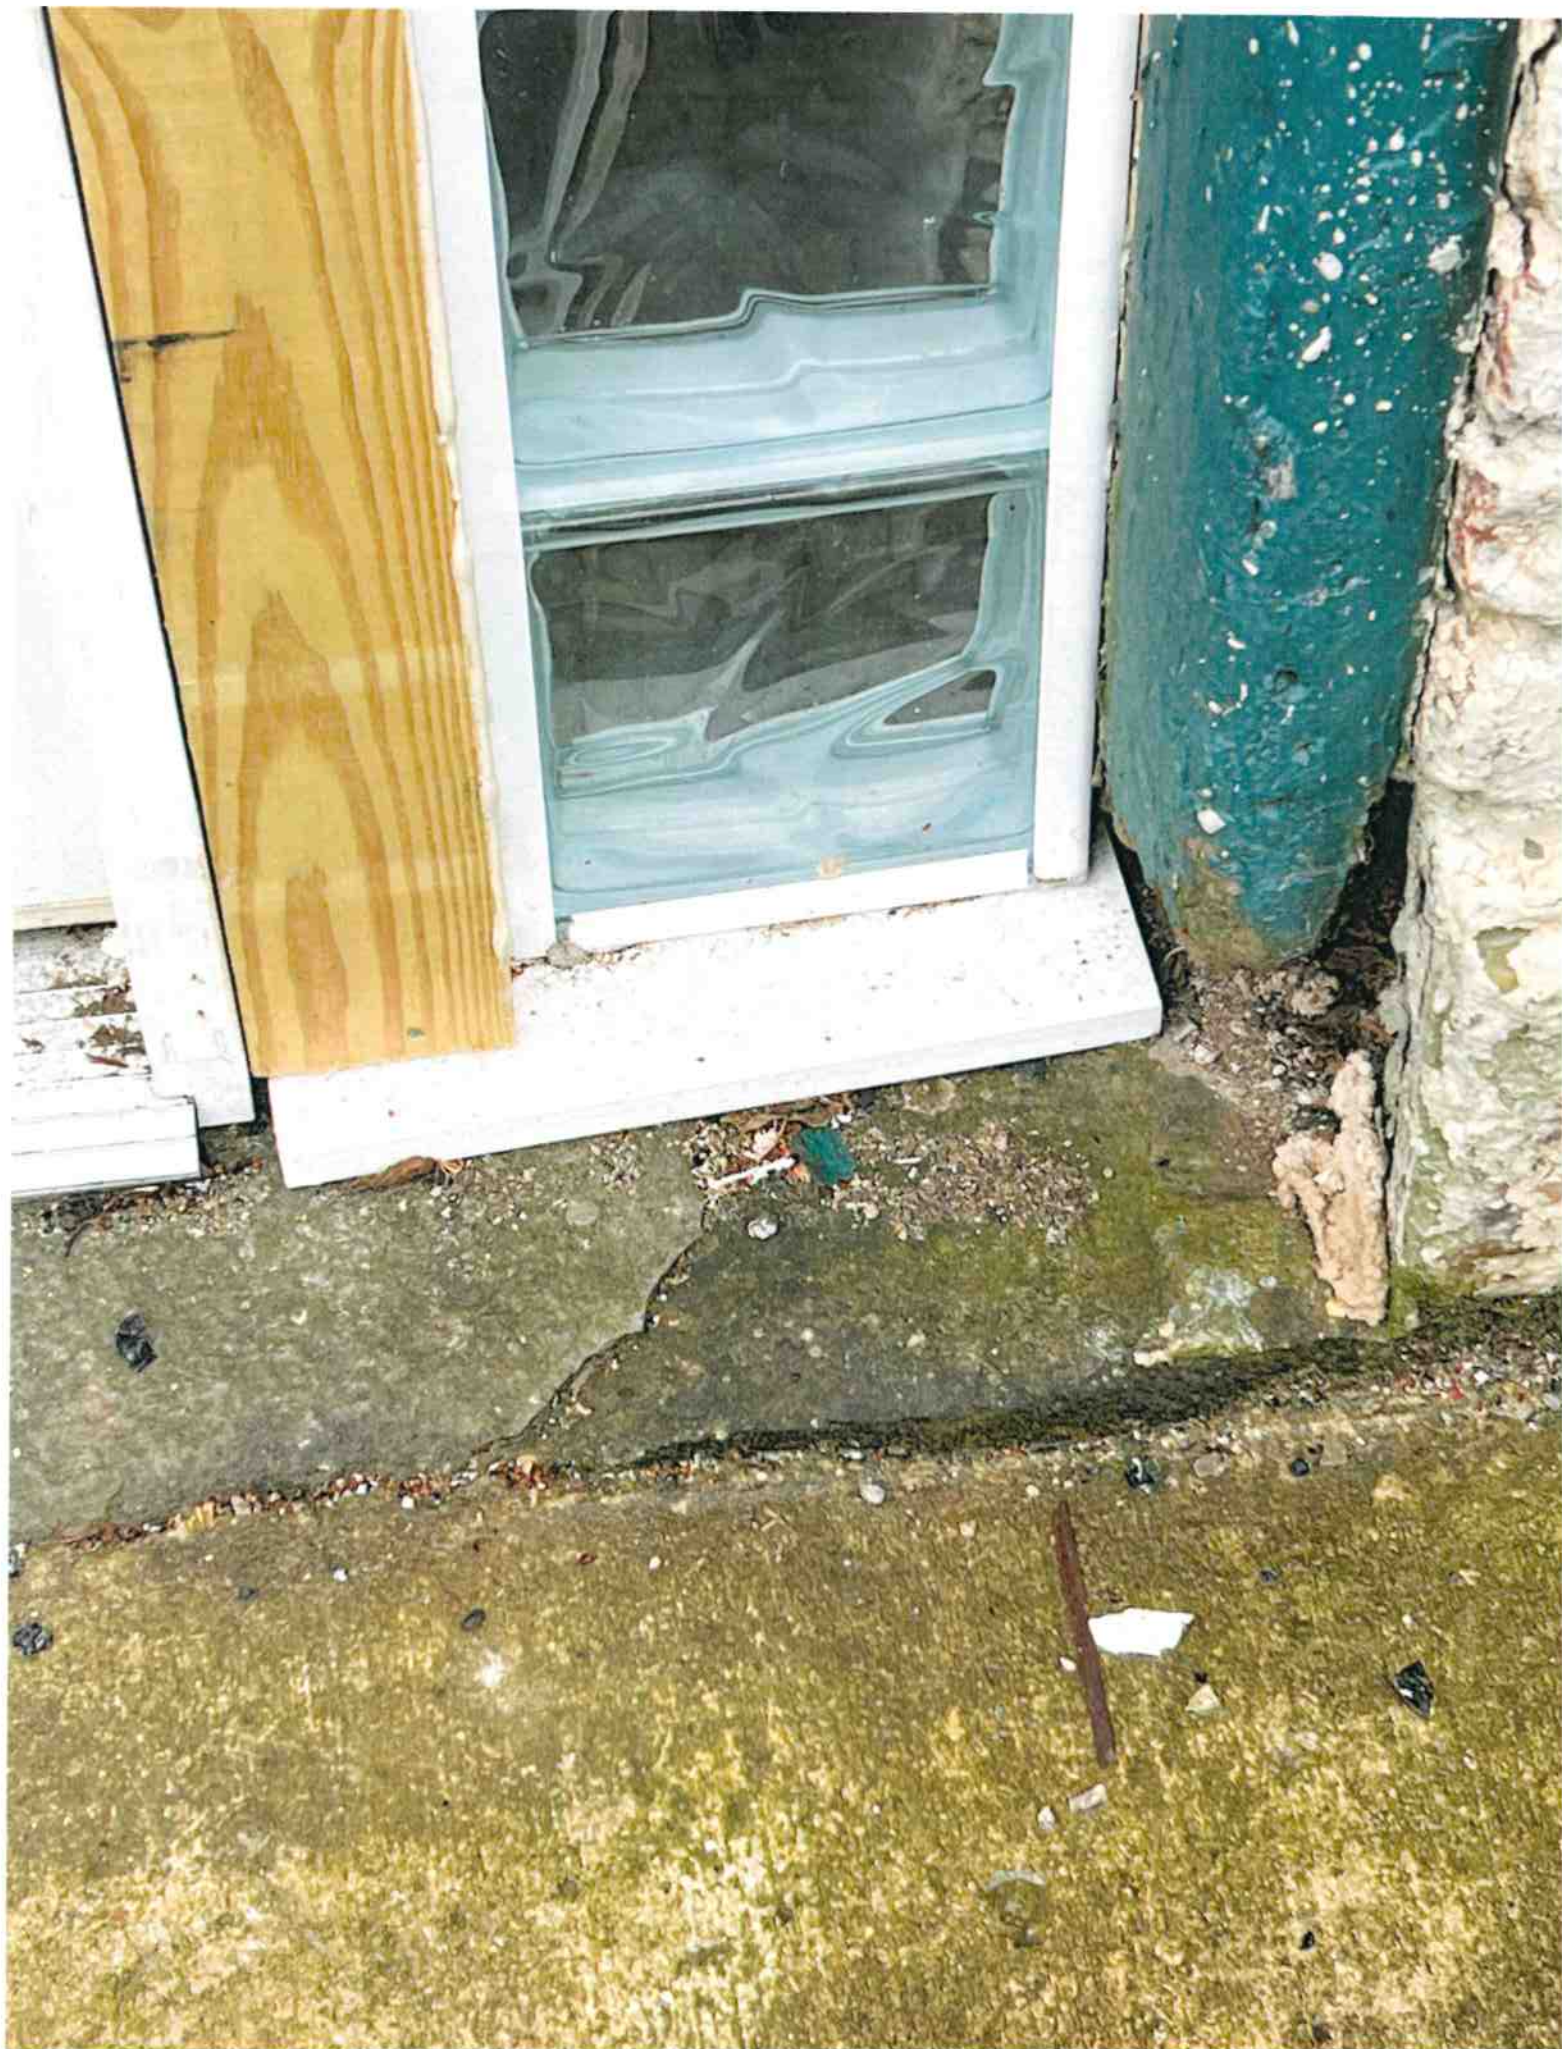
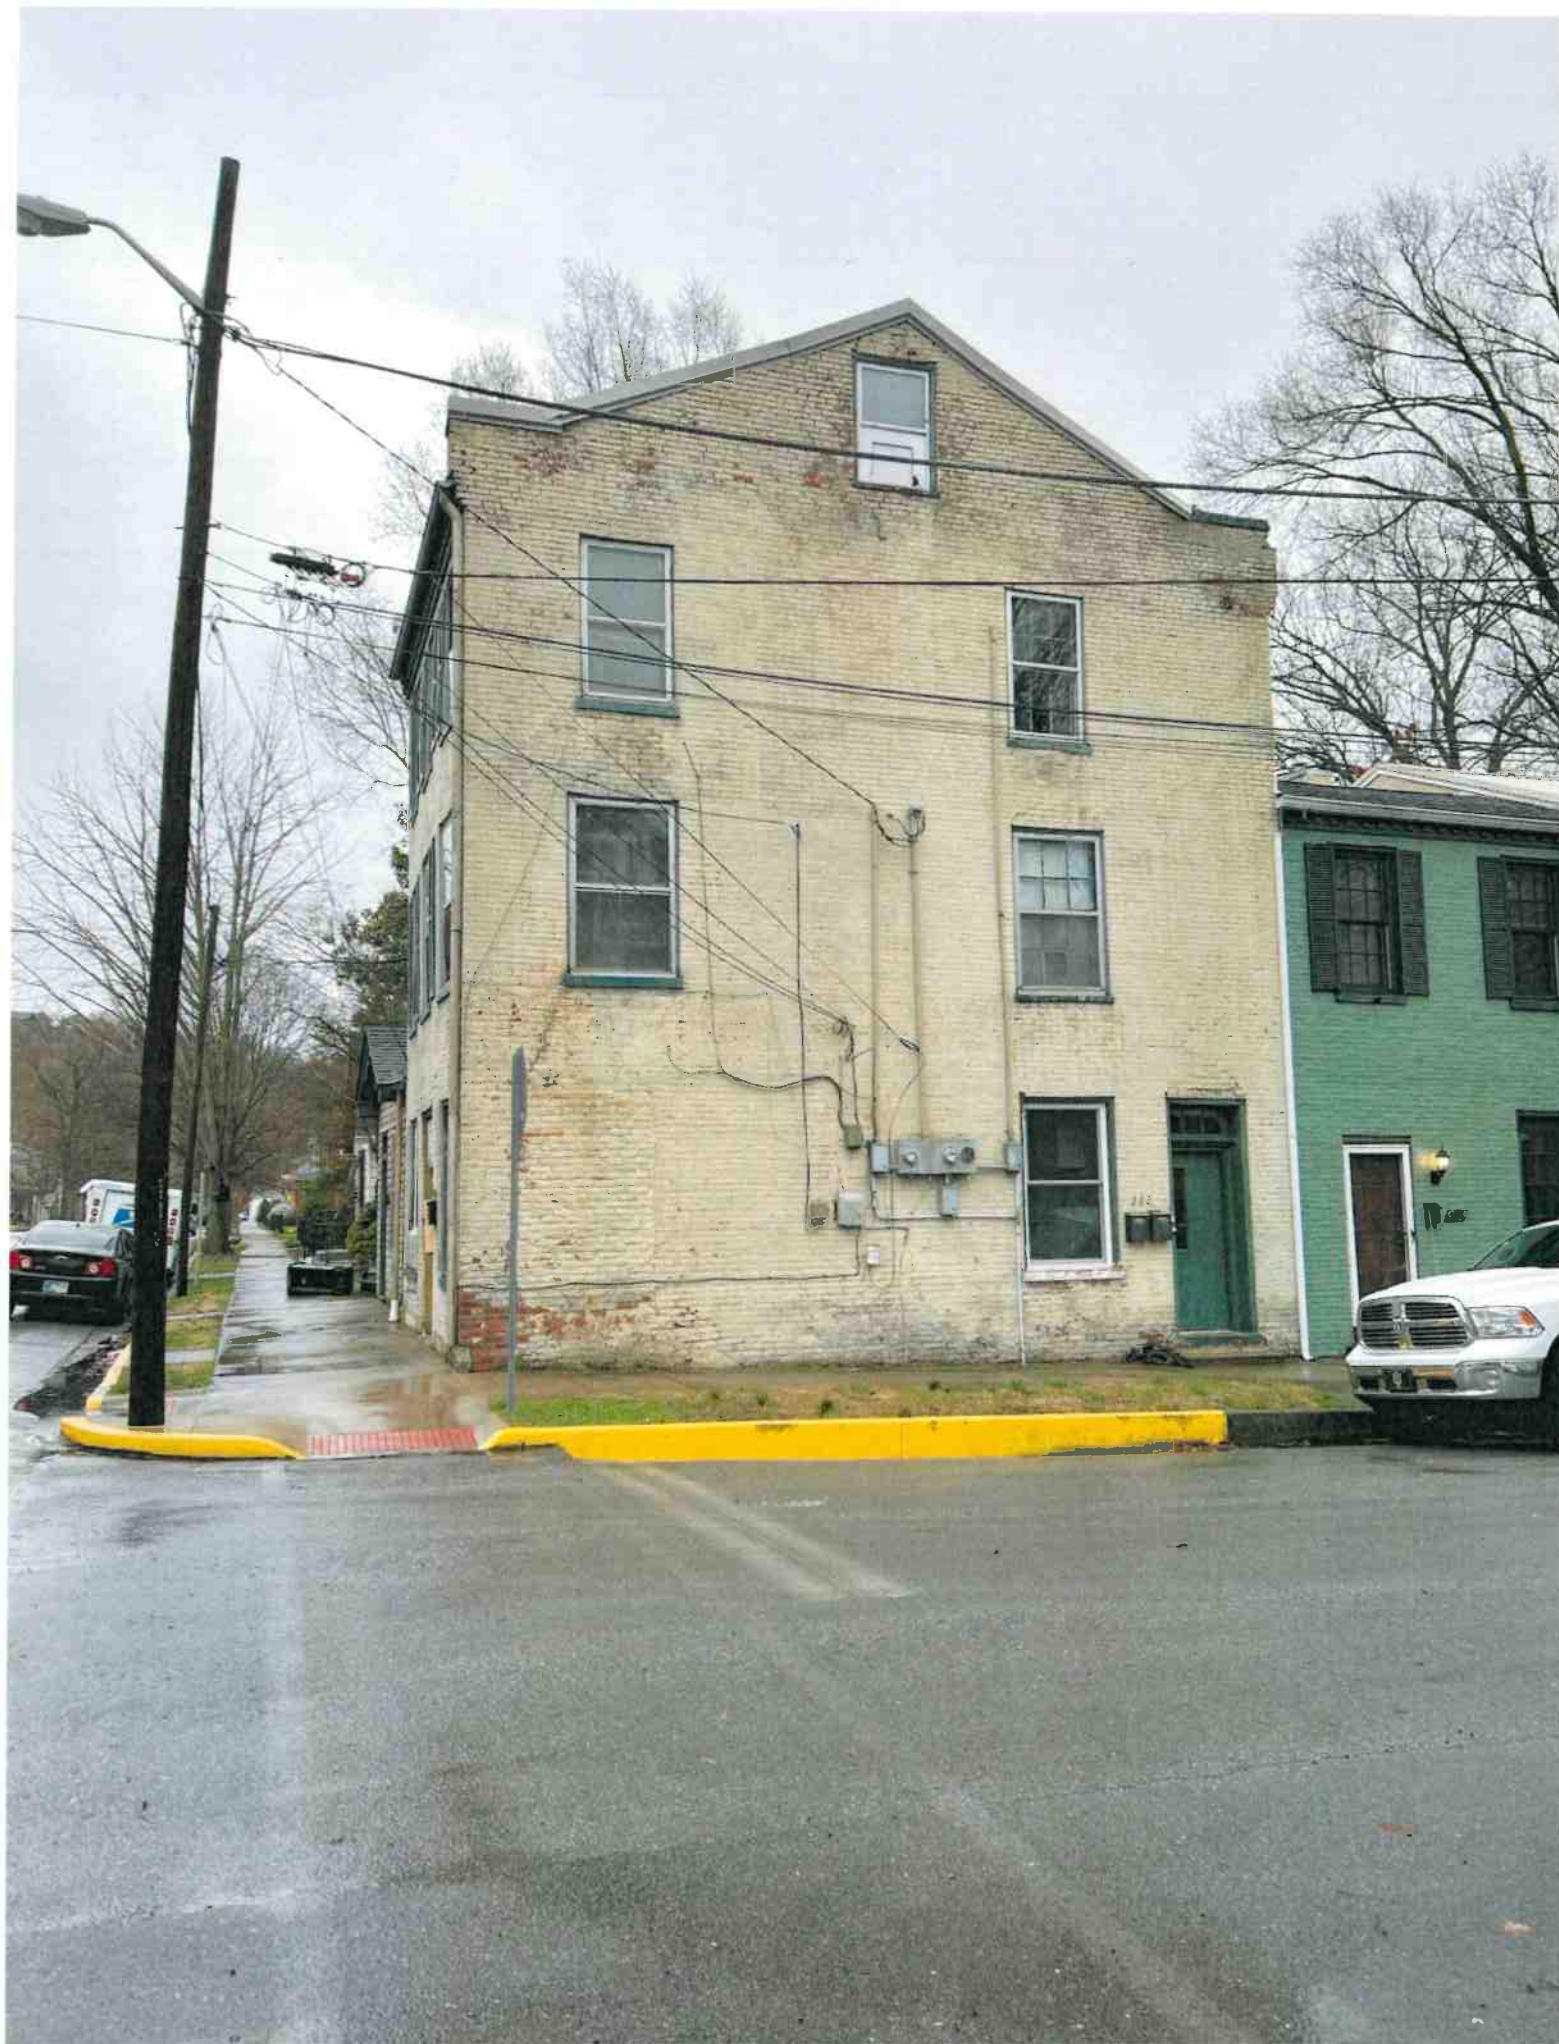
The project is *not* in conformance with Guideline 9.1 because the new door, transom, and sidelite/ infill is not compatible architecturally with the style of the structure (e.g., the door is a more modern Craftsman style but the structure is federal – see above historical information section), the transom has been covered, the sidelite infill of glass brick is not compatible architecturally with the style of the structure

and does not replicate the appearance of a multi-pane sidelite; is *not* in conformance with Guideline 9.2 because the alterations have drastically changed the historic character - the transom has been covered, the door installed more to the east than it previously was installed (and appears to be a wider door), thus deleting the eastern sidelite, and the installation of the glass blocks are not compatible (see previous conformance statement); is *not* in conformance with Guideline 9.5 because the replacement door reflects a later architectural style and is not compatible with federal architectural design; is *not* in conformance with Guideline 18.3 because there has been no evidence presented to support the 80% deterioration standard that exists to warrant complete replacement windows; is *not* in conformance with Guideline 18.4 because the replacement windows are vinyl, installed on a highly visible front façade, and do not match original detailing (see historical information regarding windows); is *not* in conformance with the ordinance because the changes greatly interrupt the rhythm of entrance and relationship of materials due to non-compatibility (see conformance statements above).

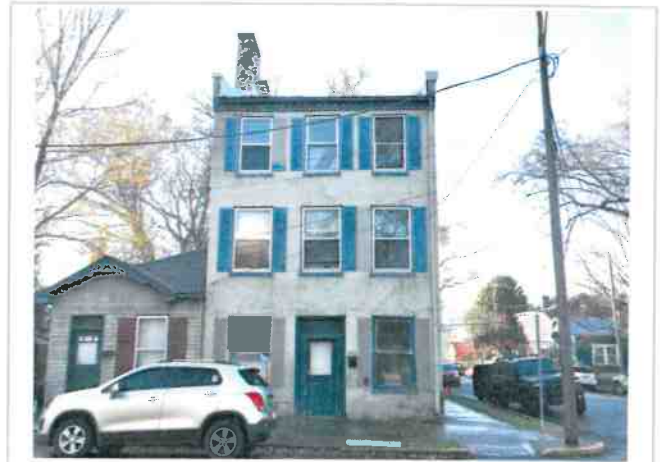
This is a 3-story house in the Federal style built in 1840. The building is rectangular in plan. The structural system is masonry. The foundation is stone. Exterior walls are brick. Brick is common bond. The building has a side gable roof and dentils. Side gabled low pitch with double gable end parapet chimneys, brick corbelling and dentils at front cornice. There are two side left, brick chimneys. Windows are wood, 1/1 double-hung sashes. 1/1 replacement windows in openings with dressed stone sills, shutters. Recessed upper-light door with blocked transom.
