**AMERICANS WITH DISABILITIES
ACT (ADA) TRANSITION PLAN FOR
PUBLIC FACILITIES and SIDEWALK
ASSET MANAGEMENT PLAN**

**Madison City Hall
101 West Main Street
Madison, IN 47250**

September 7, 2021

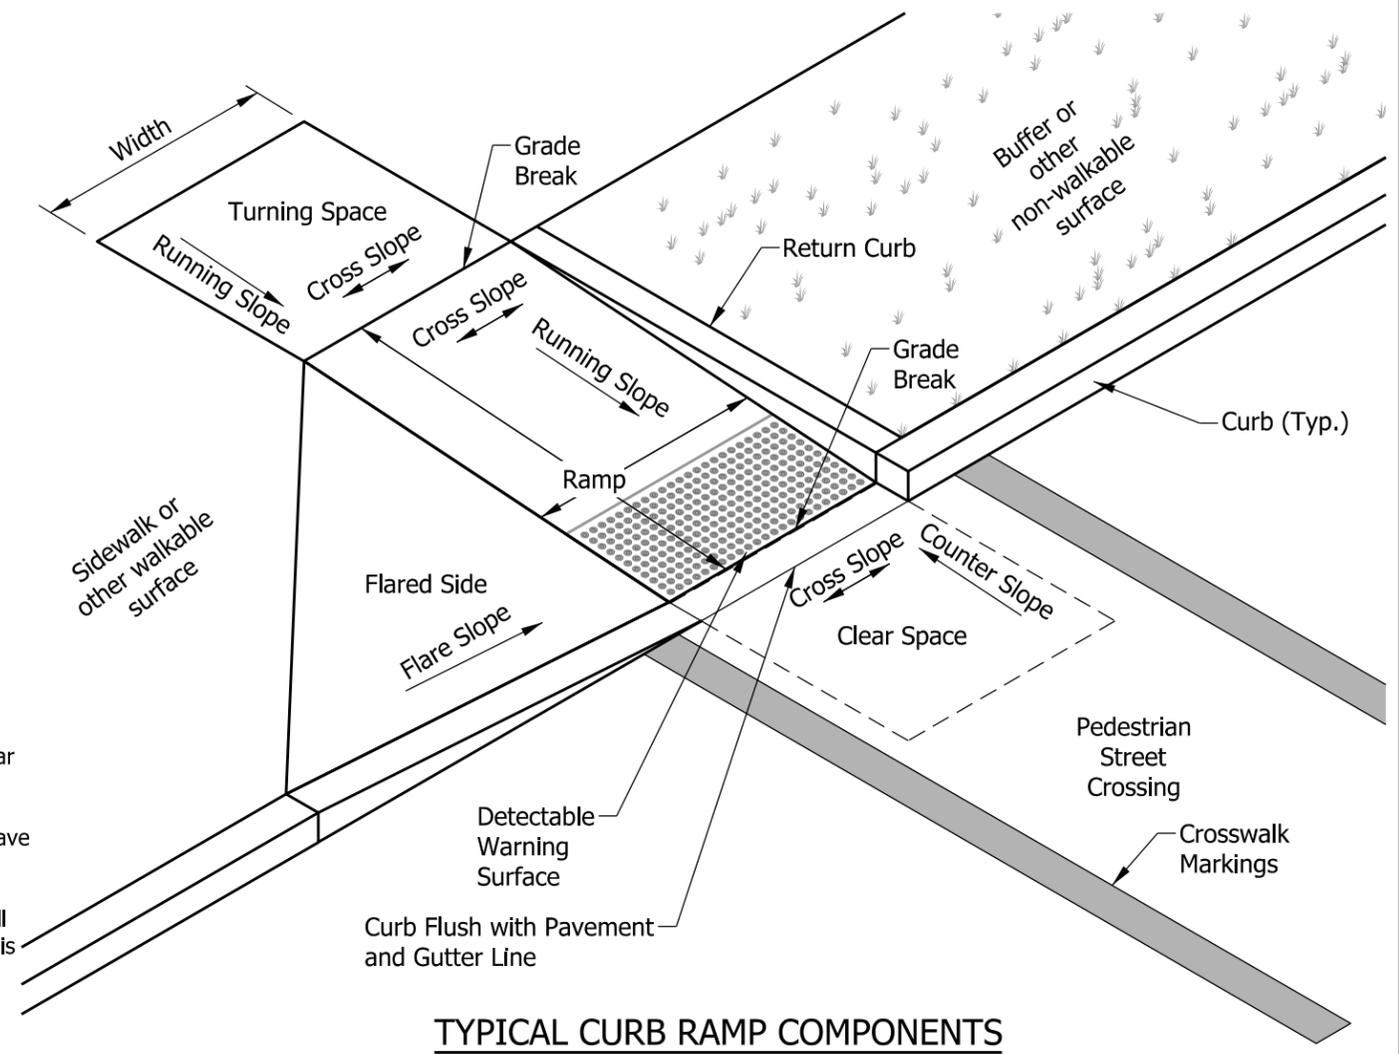
TYPICAL CURB RAMP COMPONENTS

- A turning space shall have a maximum running slope of 2.00%.
- Width. Unless otherwise noted, minimum width of a ramp, blended transition, or turning space, excluding flared sides or return curb, shall be 4 ft.

- Drainage inlets should be located uphill from a curb ramp to prevent ponding in the path of pedestrian travel.

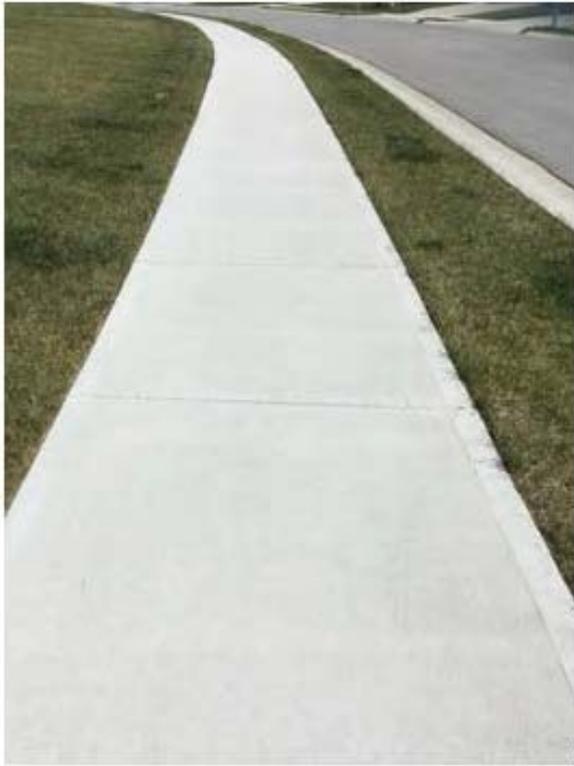
CONCRETE RATING 10

EXCELLENT – Like-new pavement. Some traffic and surface wear. No maintenance required.

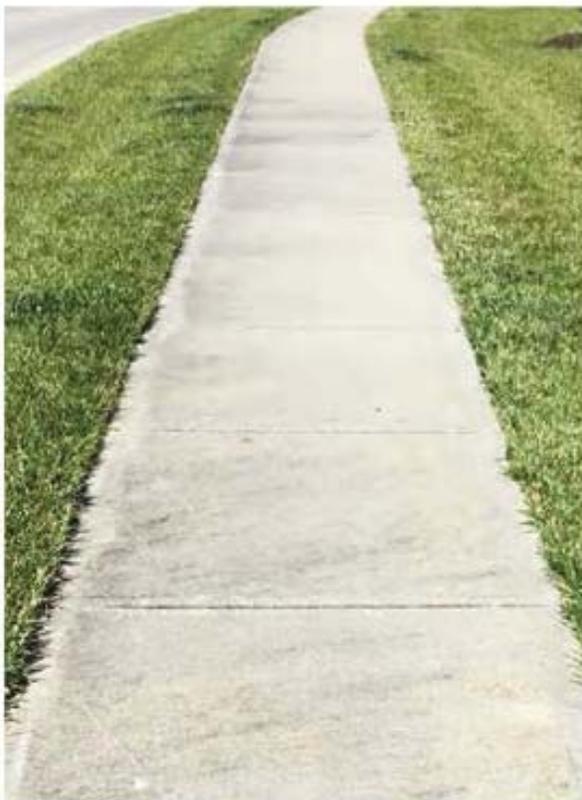
EXCELLENT – New pavement. No maintenance required.

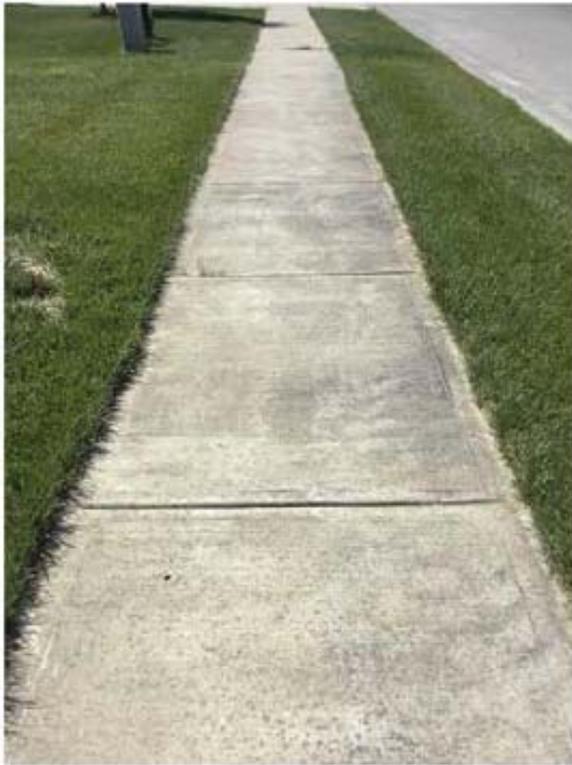
CONCRETE RATING 8

VERY GOOD – More surface wear or slight defects, such as minor pop-outs, slight surface scaling, partial loss of joint sealant, or isolated meander crack. Little or no maintenance required.

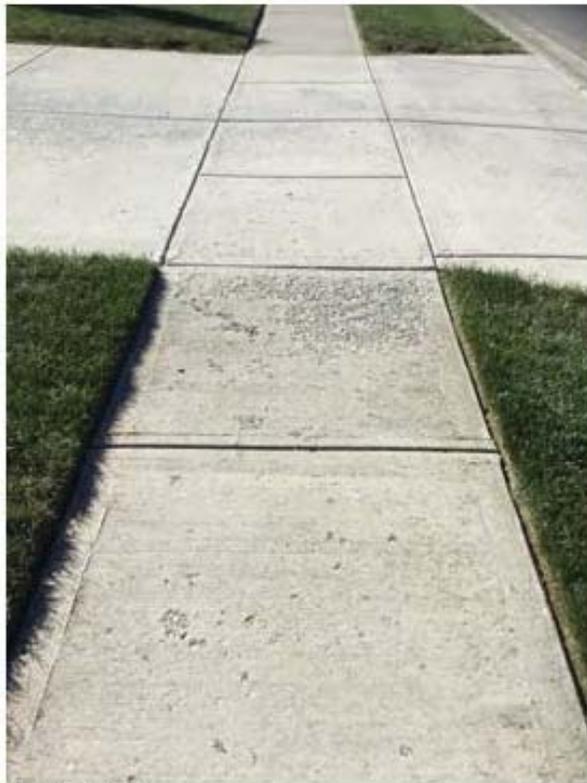
CONCRETE RATING 7

GOOD – First signs of transverse cracking, patching, or repair. More extensive pop-outs or scaling. Some manhole displacement, isolated heave or settlement. Pavement may appear unsightly, but is still functional. May require some routine maintenance.

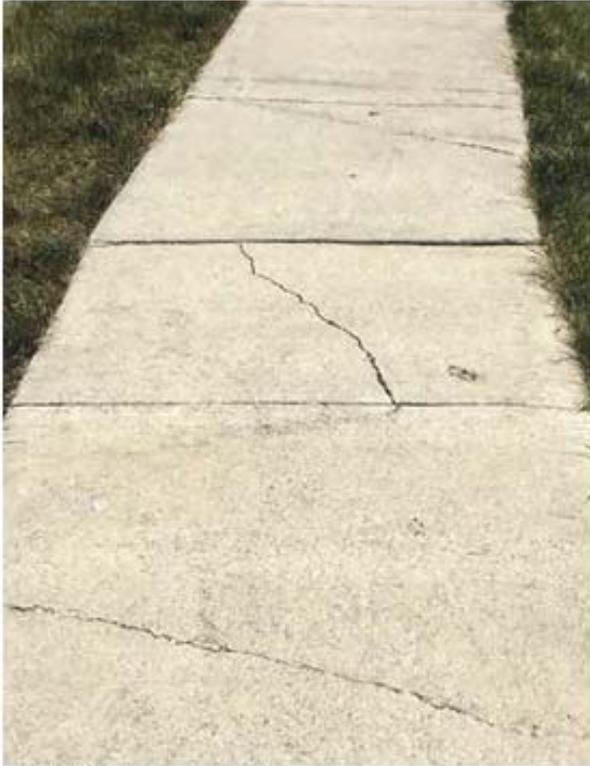
CONCRETE RATING 6

GOOD – First signs of corner cracking or shallow reinforcement. More frequent transverse cracks. Open joints and cracks (1/4"). Moderate scaling. Functionality might be a hindrance to some pedestrians. Joint and crack sealing and other routine maintenance may be needed.

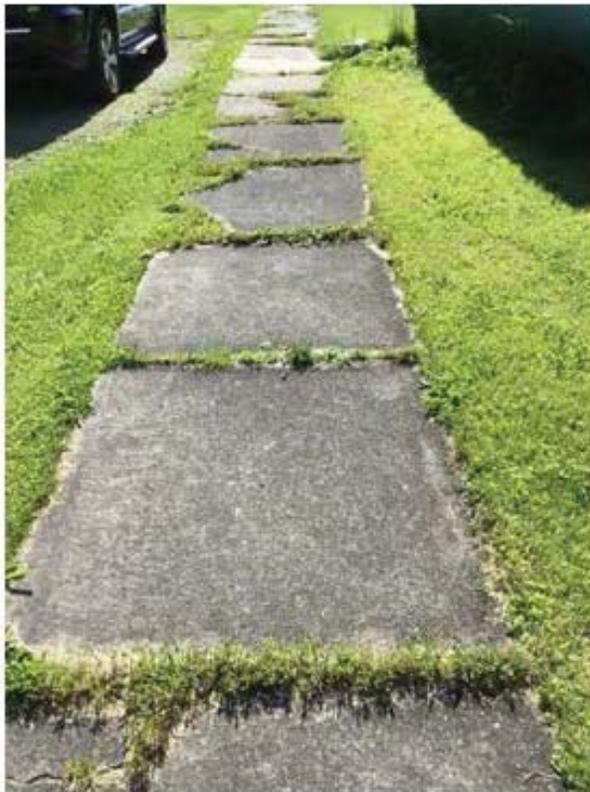
CONCRETE RATING 5

FAIR – First signs of joint or crack spalling or faulting. Multiple cracks at corners and/or broken pieces. Functionality might be a hindrance to pedestrians. Surface texturing repairs, partial depth patching, joint repairs, or panel replacement may be needed.

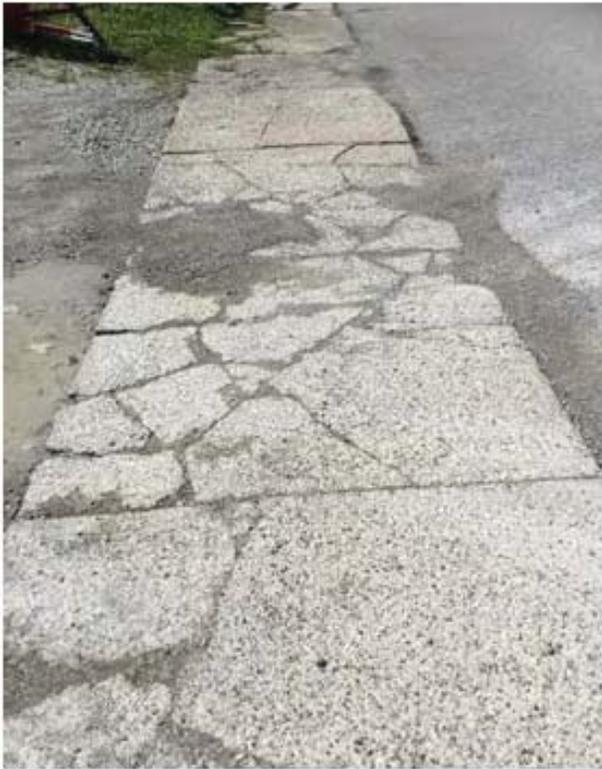
CONCRETE RATING 4

FAIR – Significant signs of joint or crack spalling or faulting. Multiple cracks at corners and broken pieces. Not easily navigated by pedestrians. Extensive surface texturing repairs, full depth joint or crack repairs, or panel replacement may be needed.

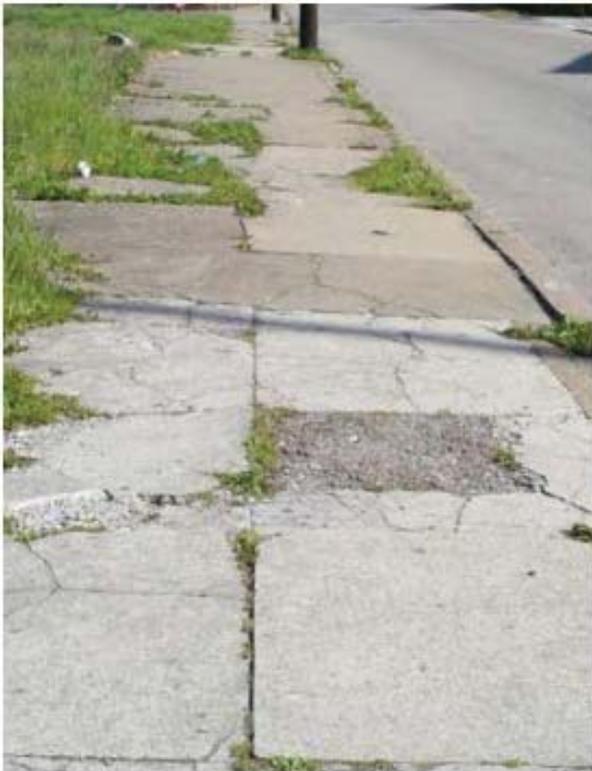
CONCRETE RATING 3

POOR – Severe joint or crack spalling or faulting. Most joints and cracks are open. Significant hindrance to pedestrians. Extensive full depth patching or multiple panel replacement may be needed.

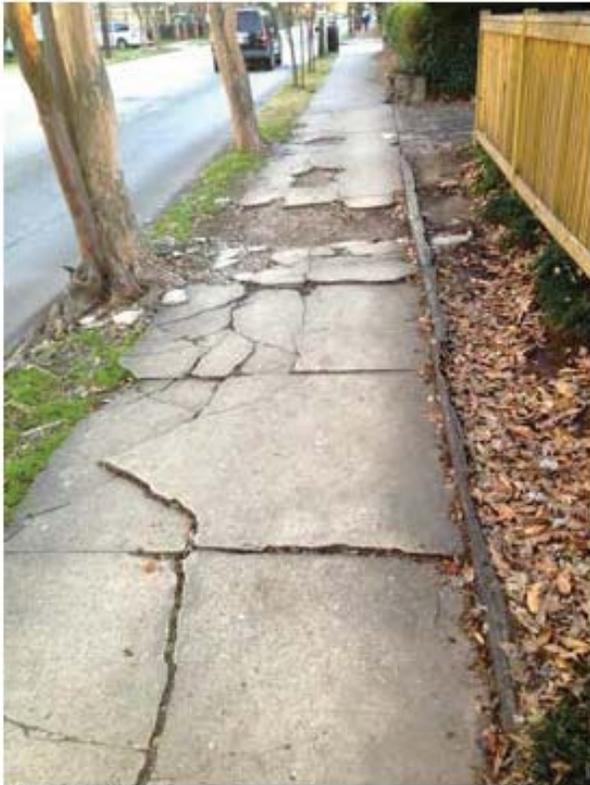
CONCRETE RATING 2

VERY POOR – Severe deterioration and extensive joint failure. Not functional for most users. Pavement recycling and reconstruction necessary.

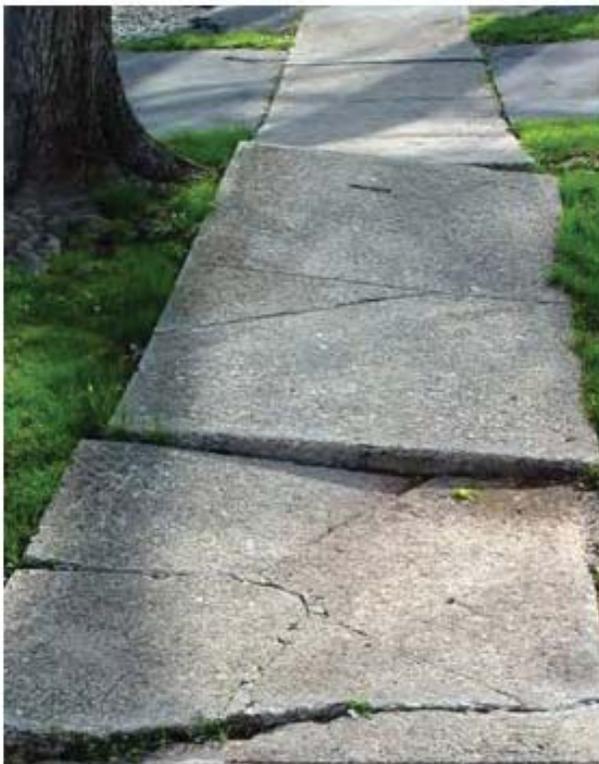
CONCRETE RATING 1

FAILED – Severe joint or crack spalling or faulting, significant heave or settlement and slab failure. Impossible to pedestrians. Complete reconstruction necessary.

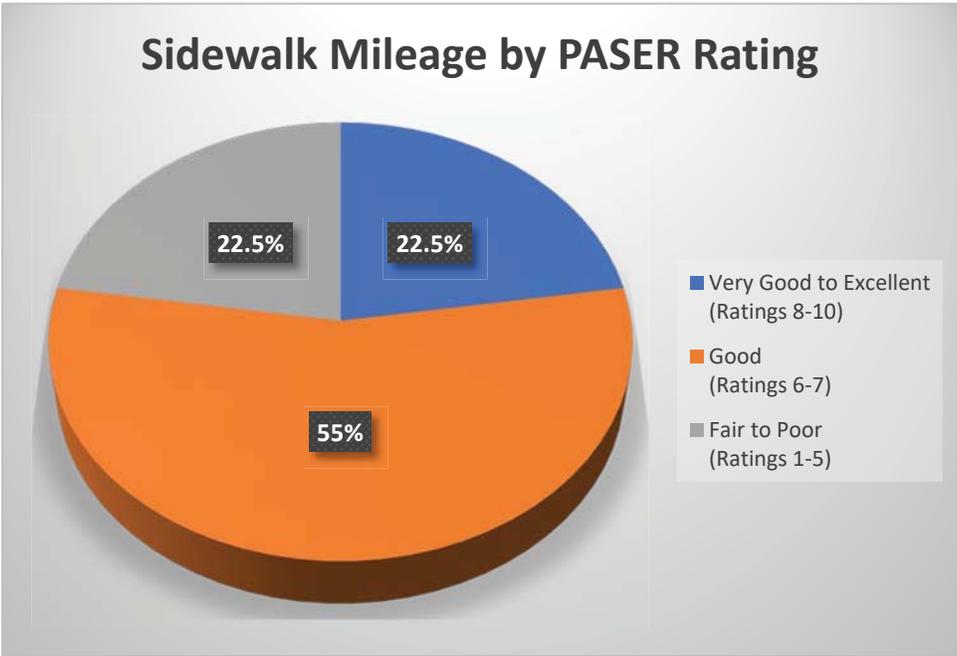
Figure 3.

9.0 miles (22.5%) or 193 segments are in very good to excellent condition (PASER ratings 8-10).

21.9 miles (55%) or 422 segments are in good condition (PASER ratings 6-7).

9.0 miles (22.5%) or 175 segments are in fair or poor condition (PASER ratings 1-5).

Figure 3 shows the breakdown of the condition of sidewalk by grouped PASER values. It should be noted that the evaluations were done by segment. If there was something within the segment that led to a fair to poor PASER rating then the whole segment was assigned that value and therefore the whole mileage was assigned the same value. Some segments involve replacing a few panels and therefore the true mileage of sidewalks in fair to poor condition should be less than what is represented below.

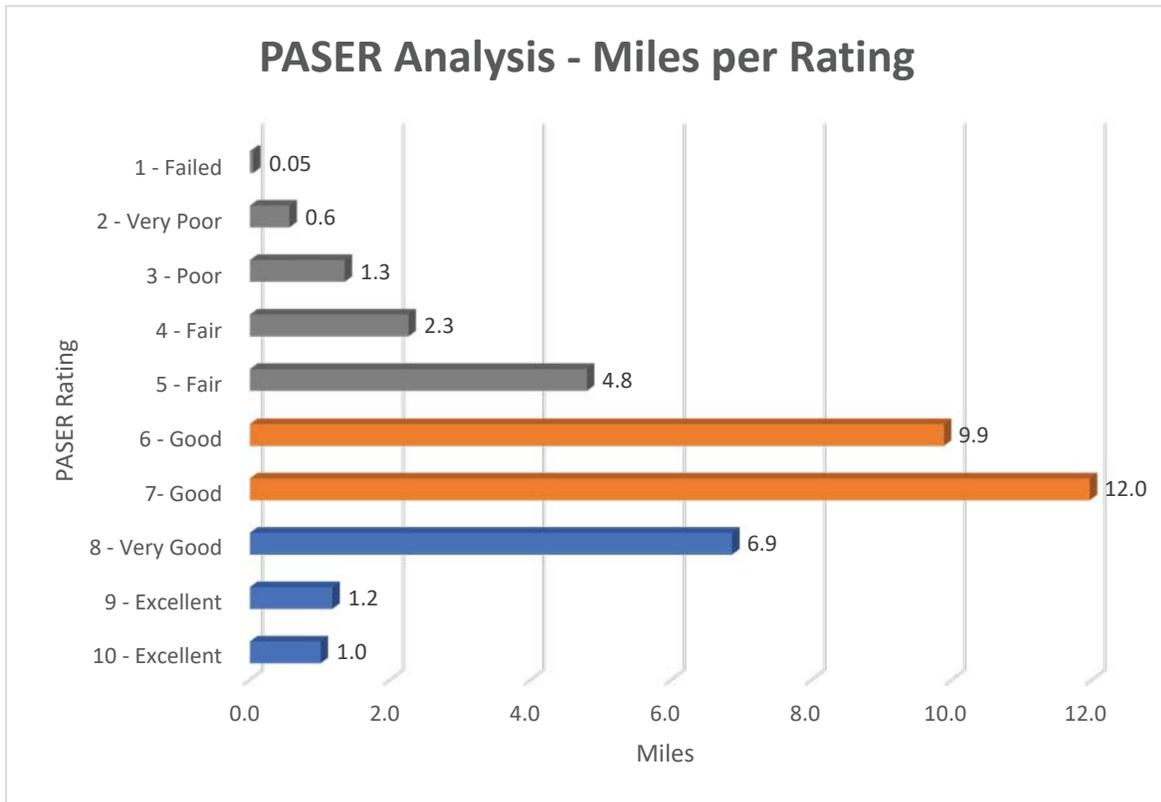
Figure 4.

Figure 4 below shows the length of concrete sidewalks according to each PASER rating. Of the 39.9 miles of concrete sidewalks, 2.2 miles are in excellent condition (ratings 9-10), and 6.9 miles are rated as very good. 31.9 miles of the concrete sidewalks fall into the good range (ratings 6-7) and will require routine maintenance and spot issue repairs. This means 9.0 miles of concrete sidewalks in the City require significant spot repairs or entire segment replacement.

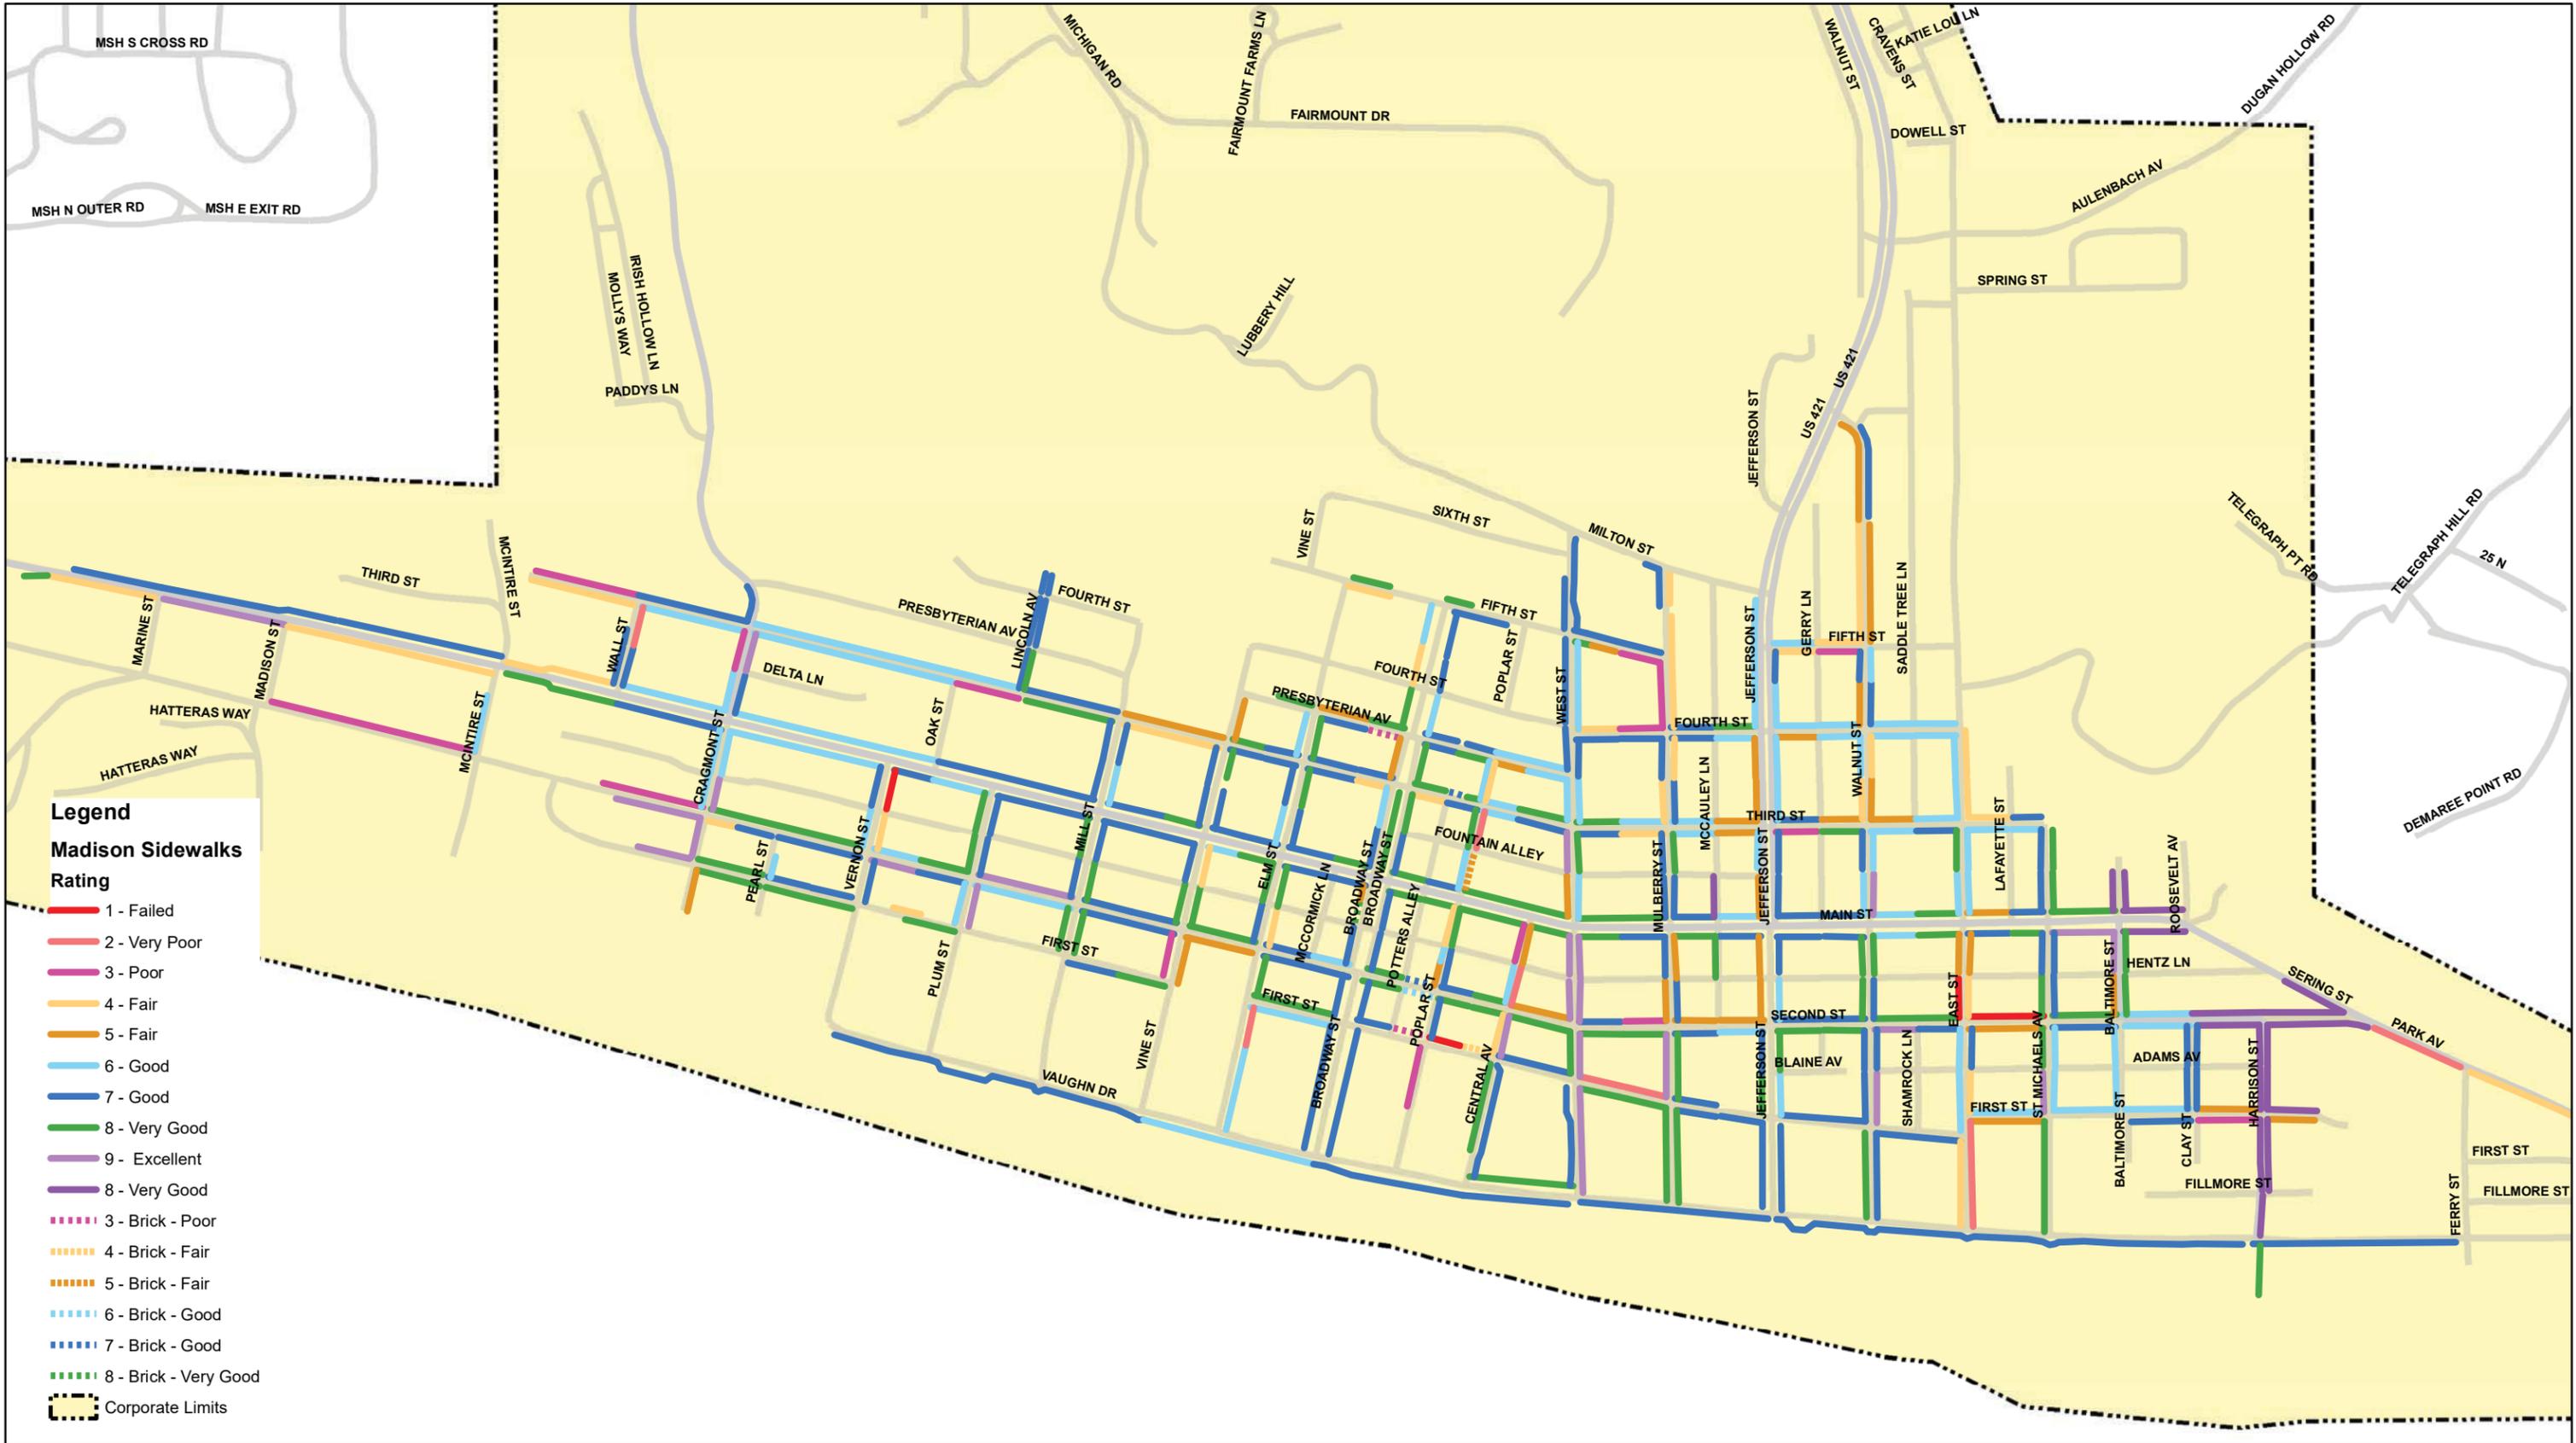
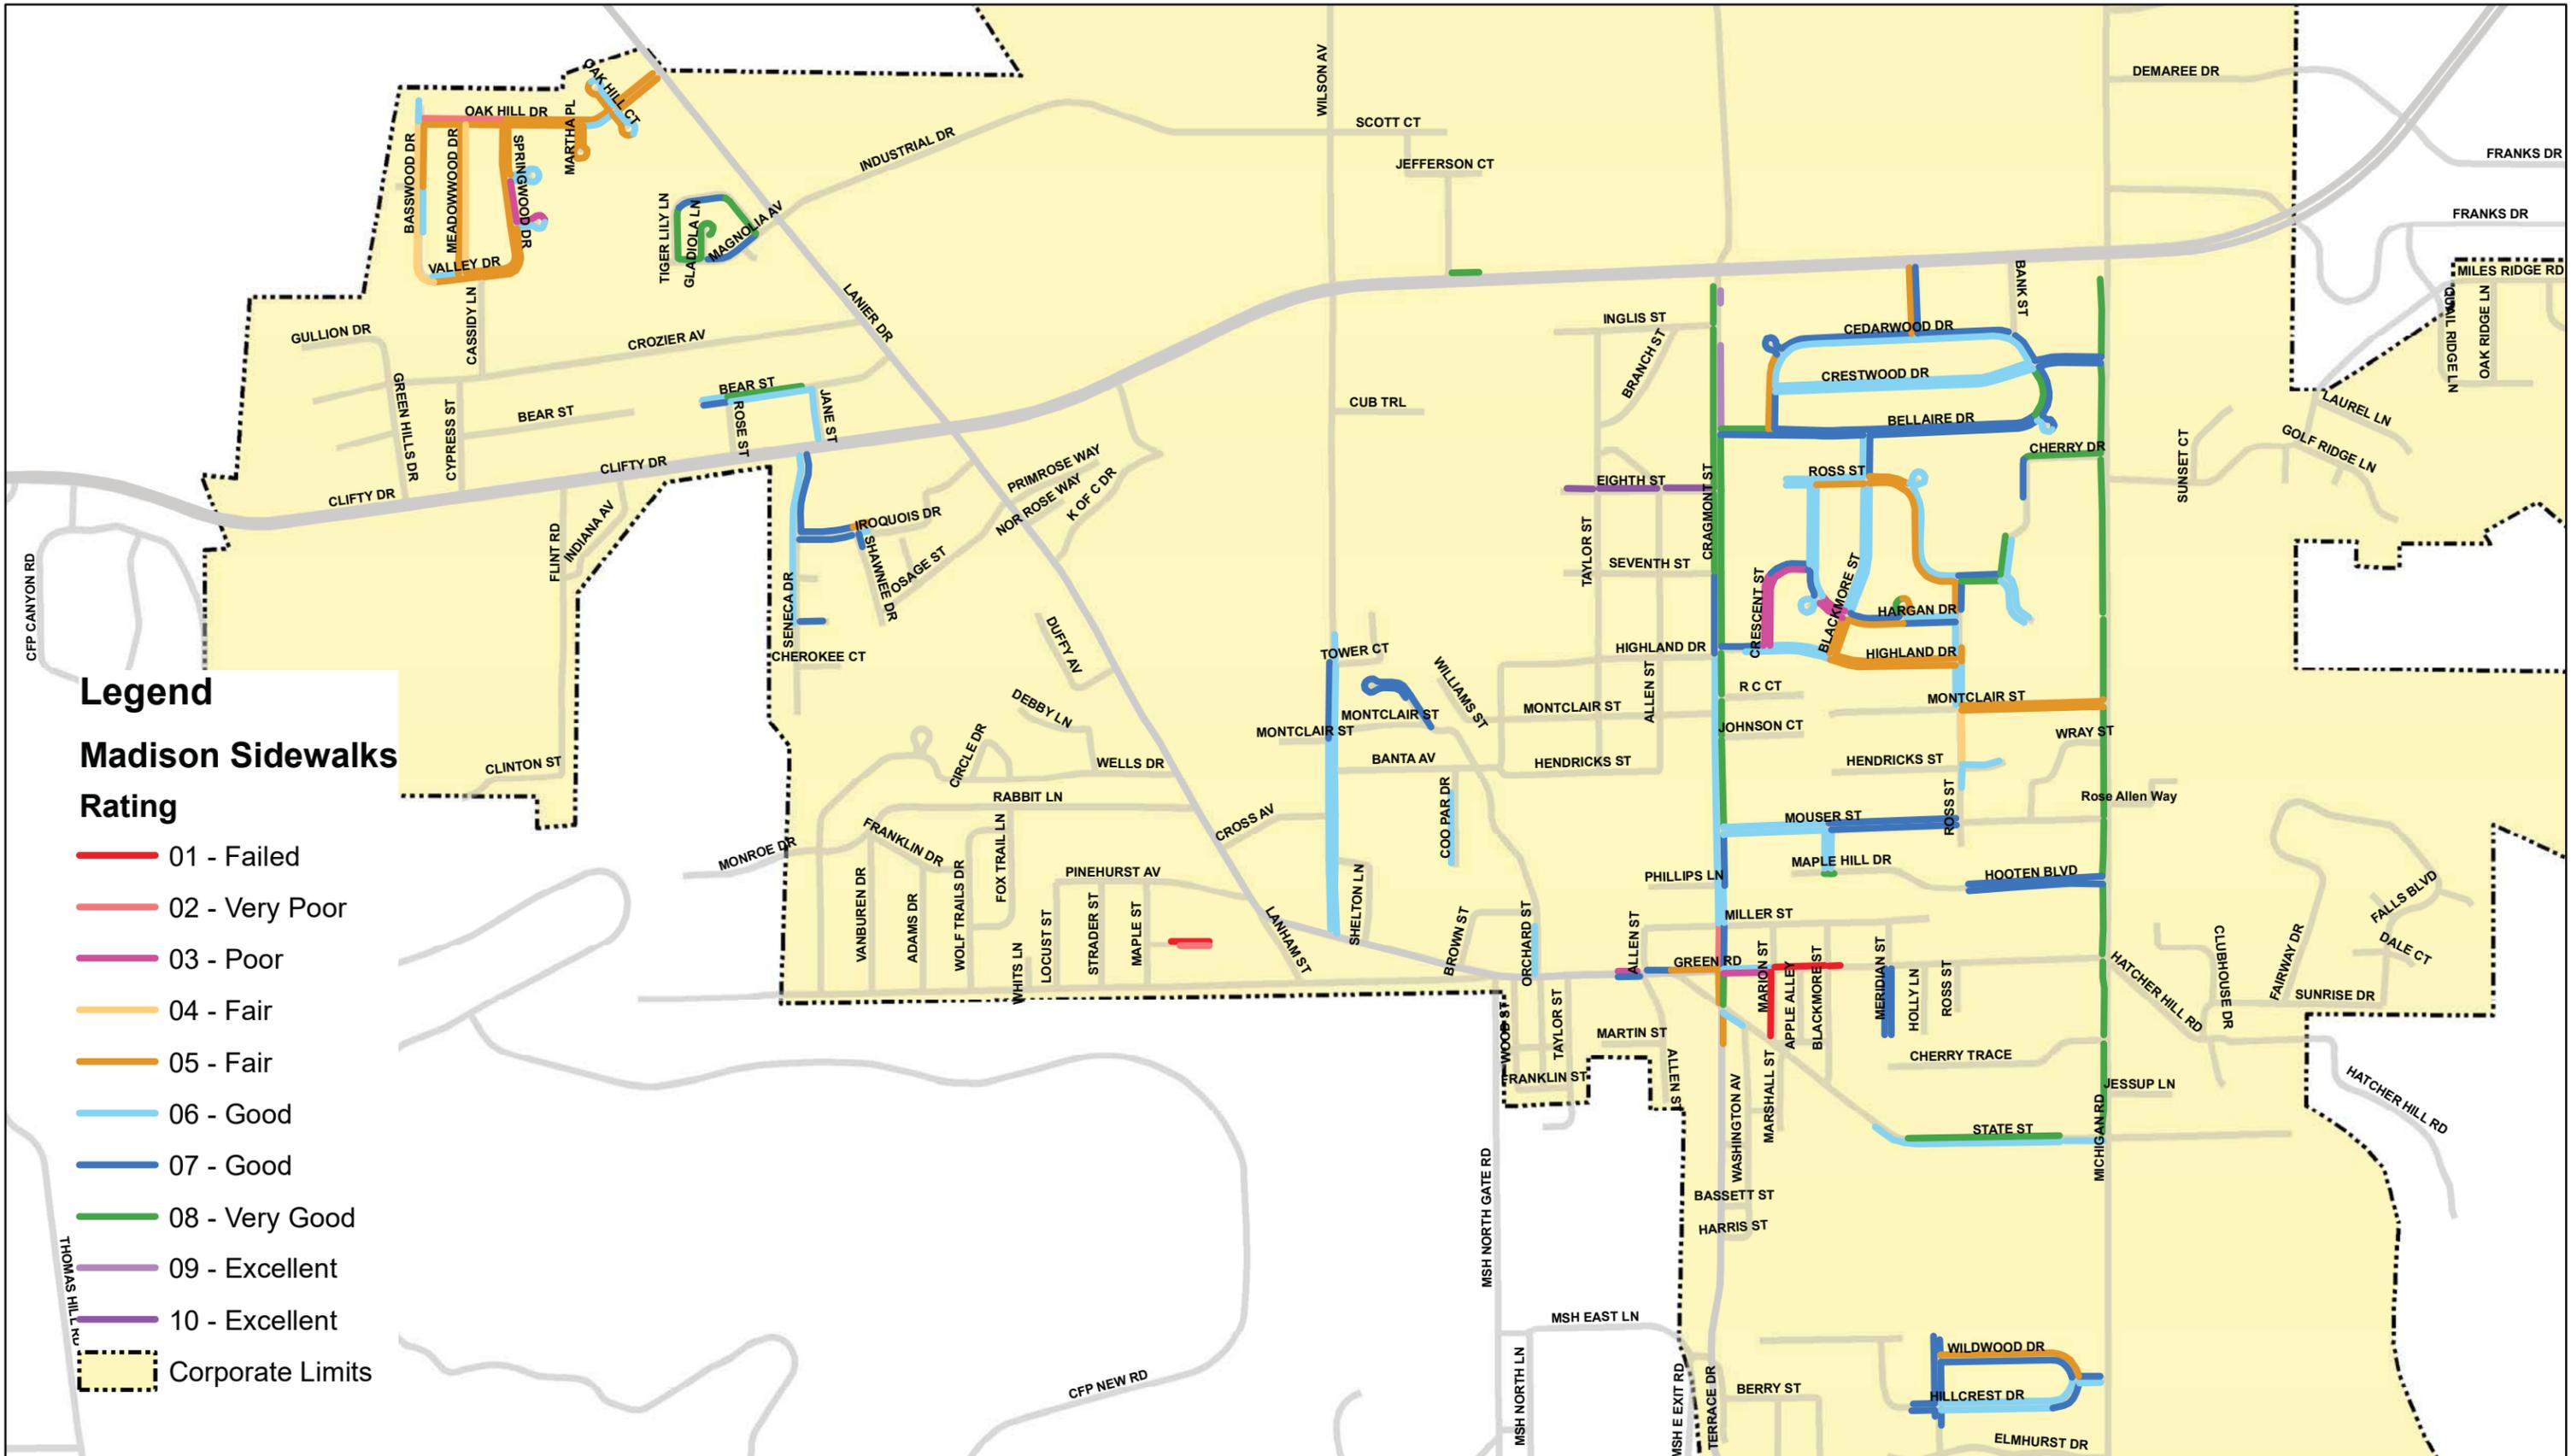
PASER Surface Rating Map 1 of 2

The PASER Surface Rating maps found at the end of the section as Exhibit 1 illustrate the pavement condition data. The Sidewalk ADA Compliancy maps found at the end of the section as Exhibit 2 illustrate the Compliant and Non-Compliant sidewalk segments.
