**AMERICANS WITH DISABILITIES
ACT (ADA) TRANSITION PLAN FOR
PUBLIC FACILITIES and SIDEWALK
ASSET MANAGEMENT PLAN**

**Madison City Hall
101 West Main Street
Madison, IN 47250**

September 7, 2021

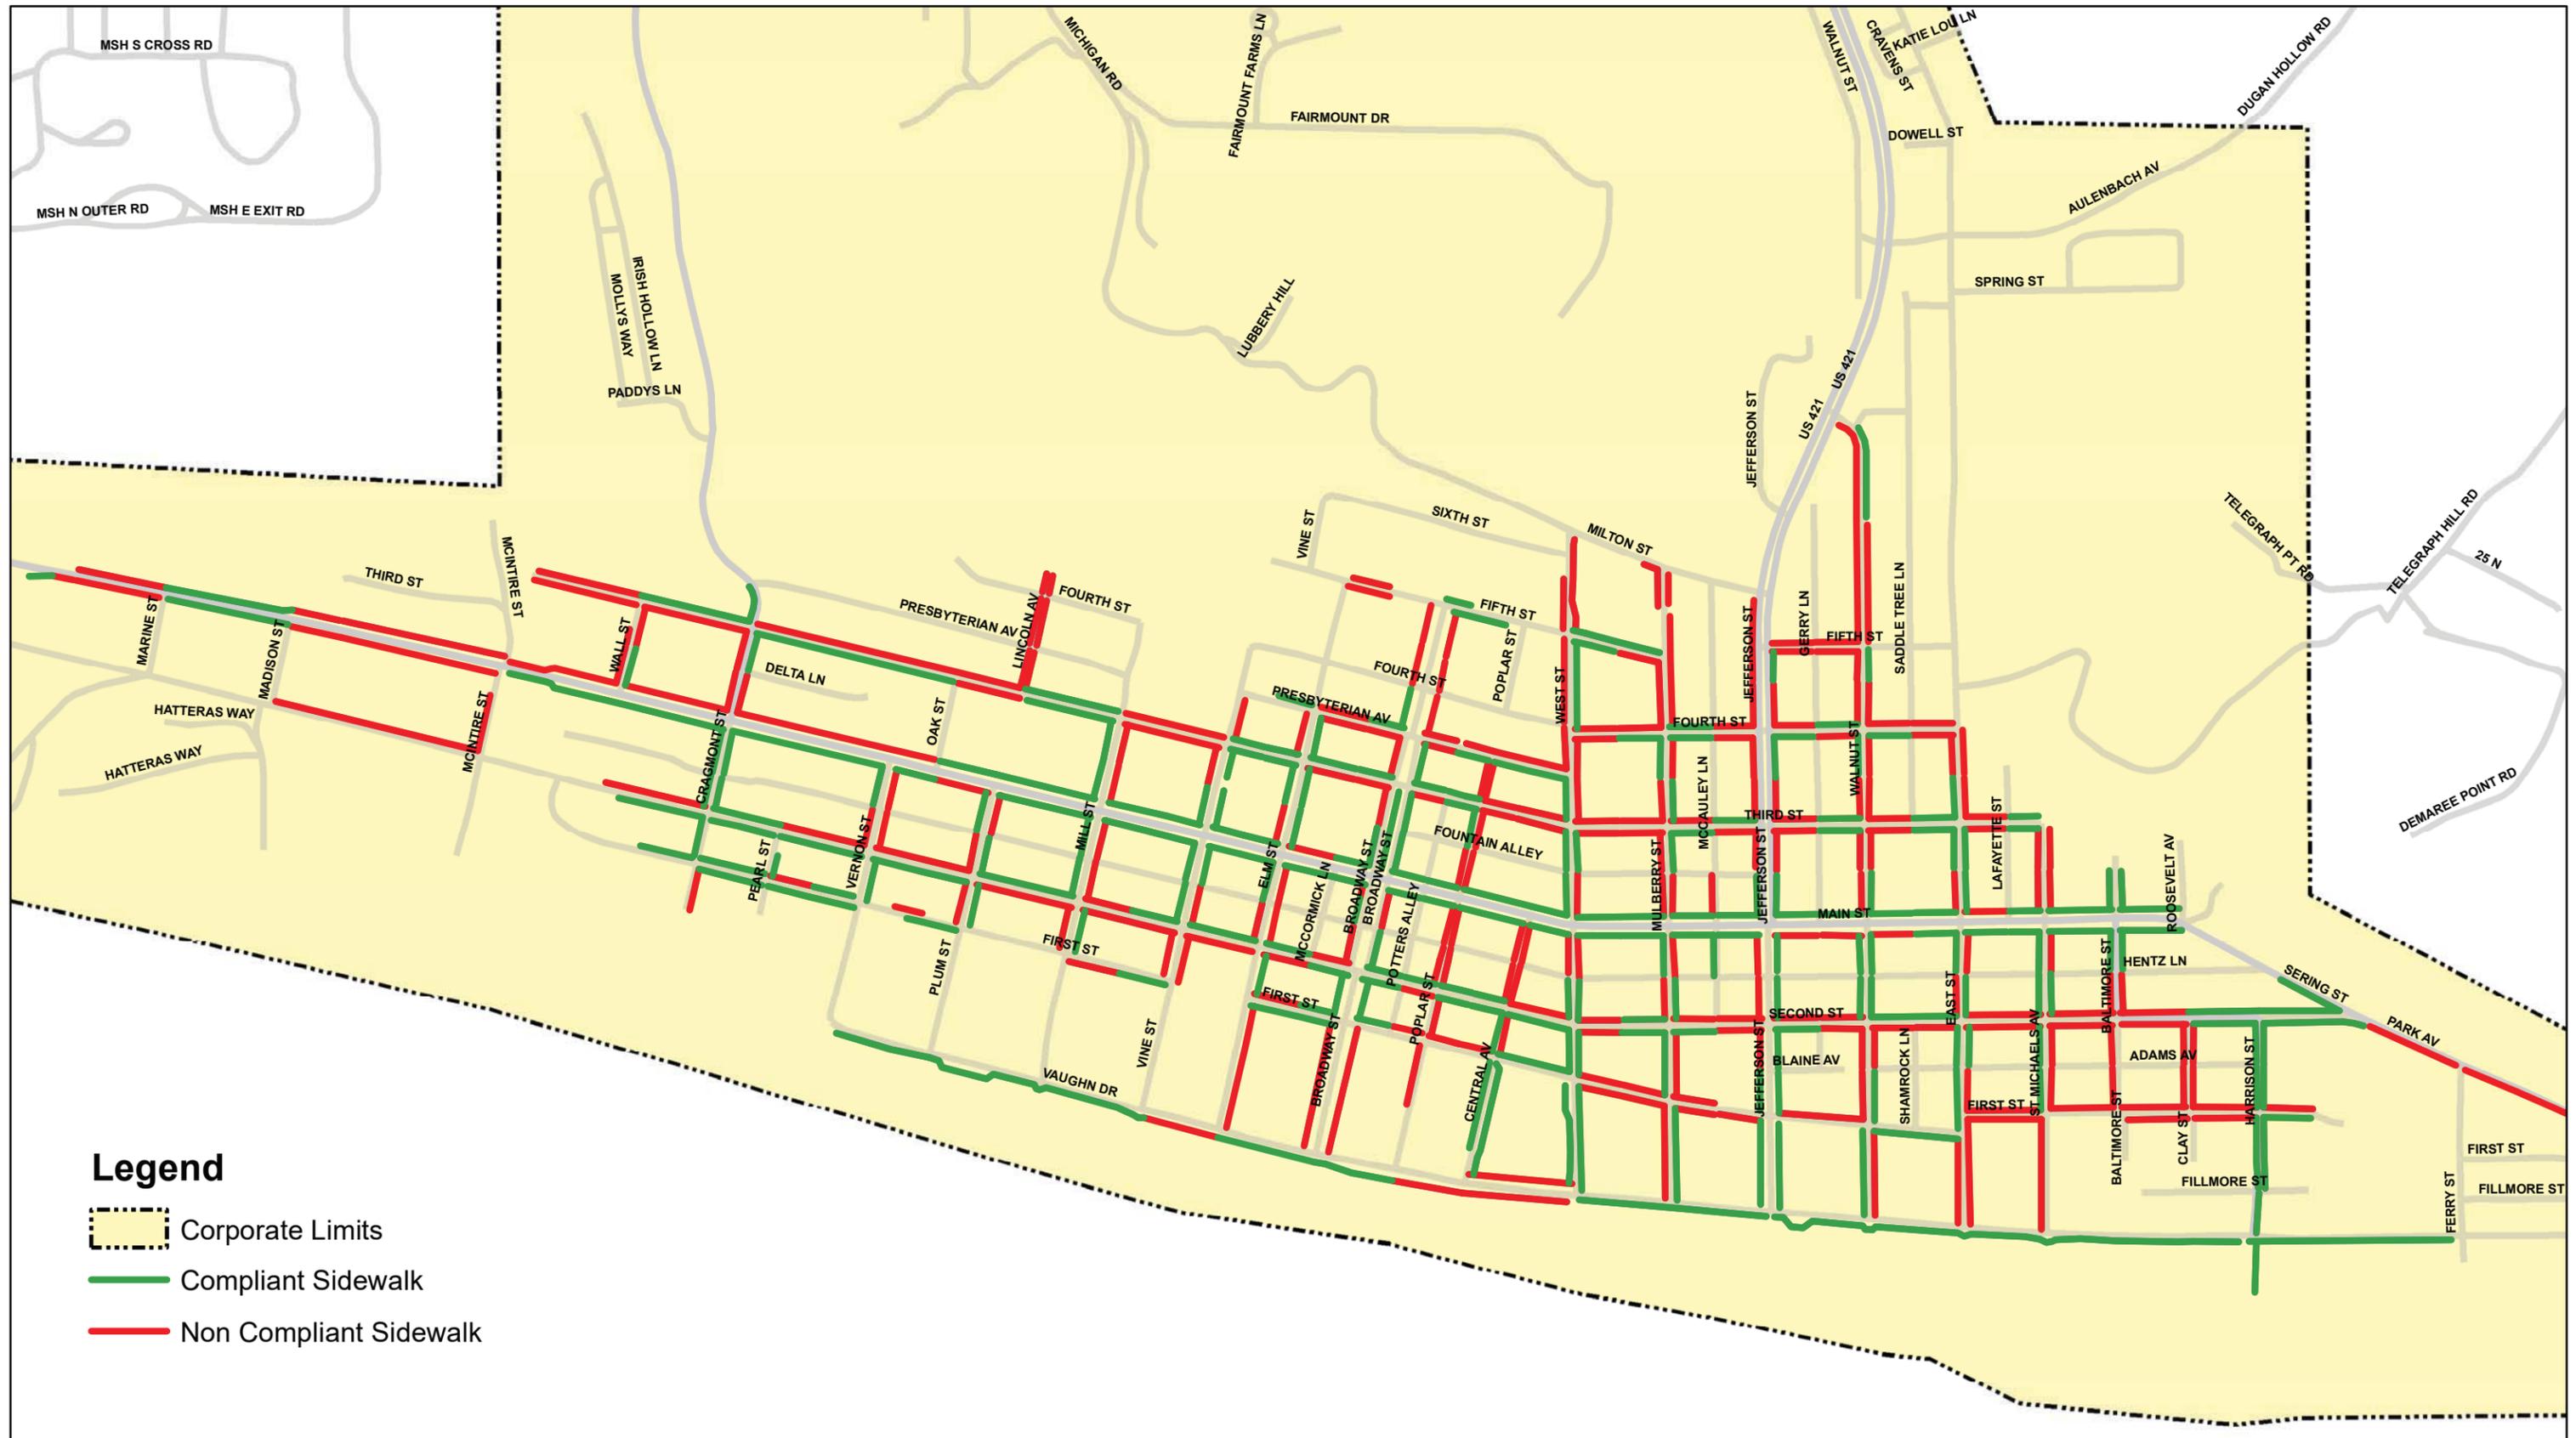
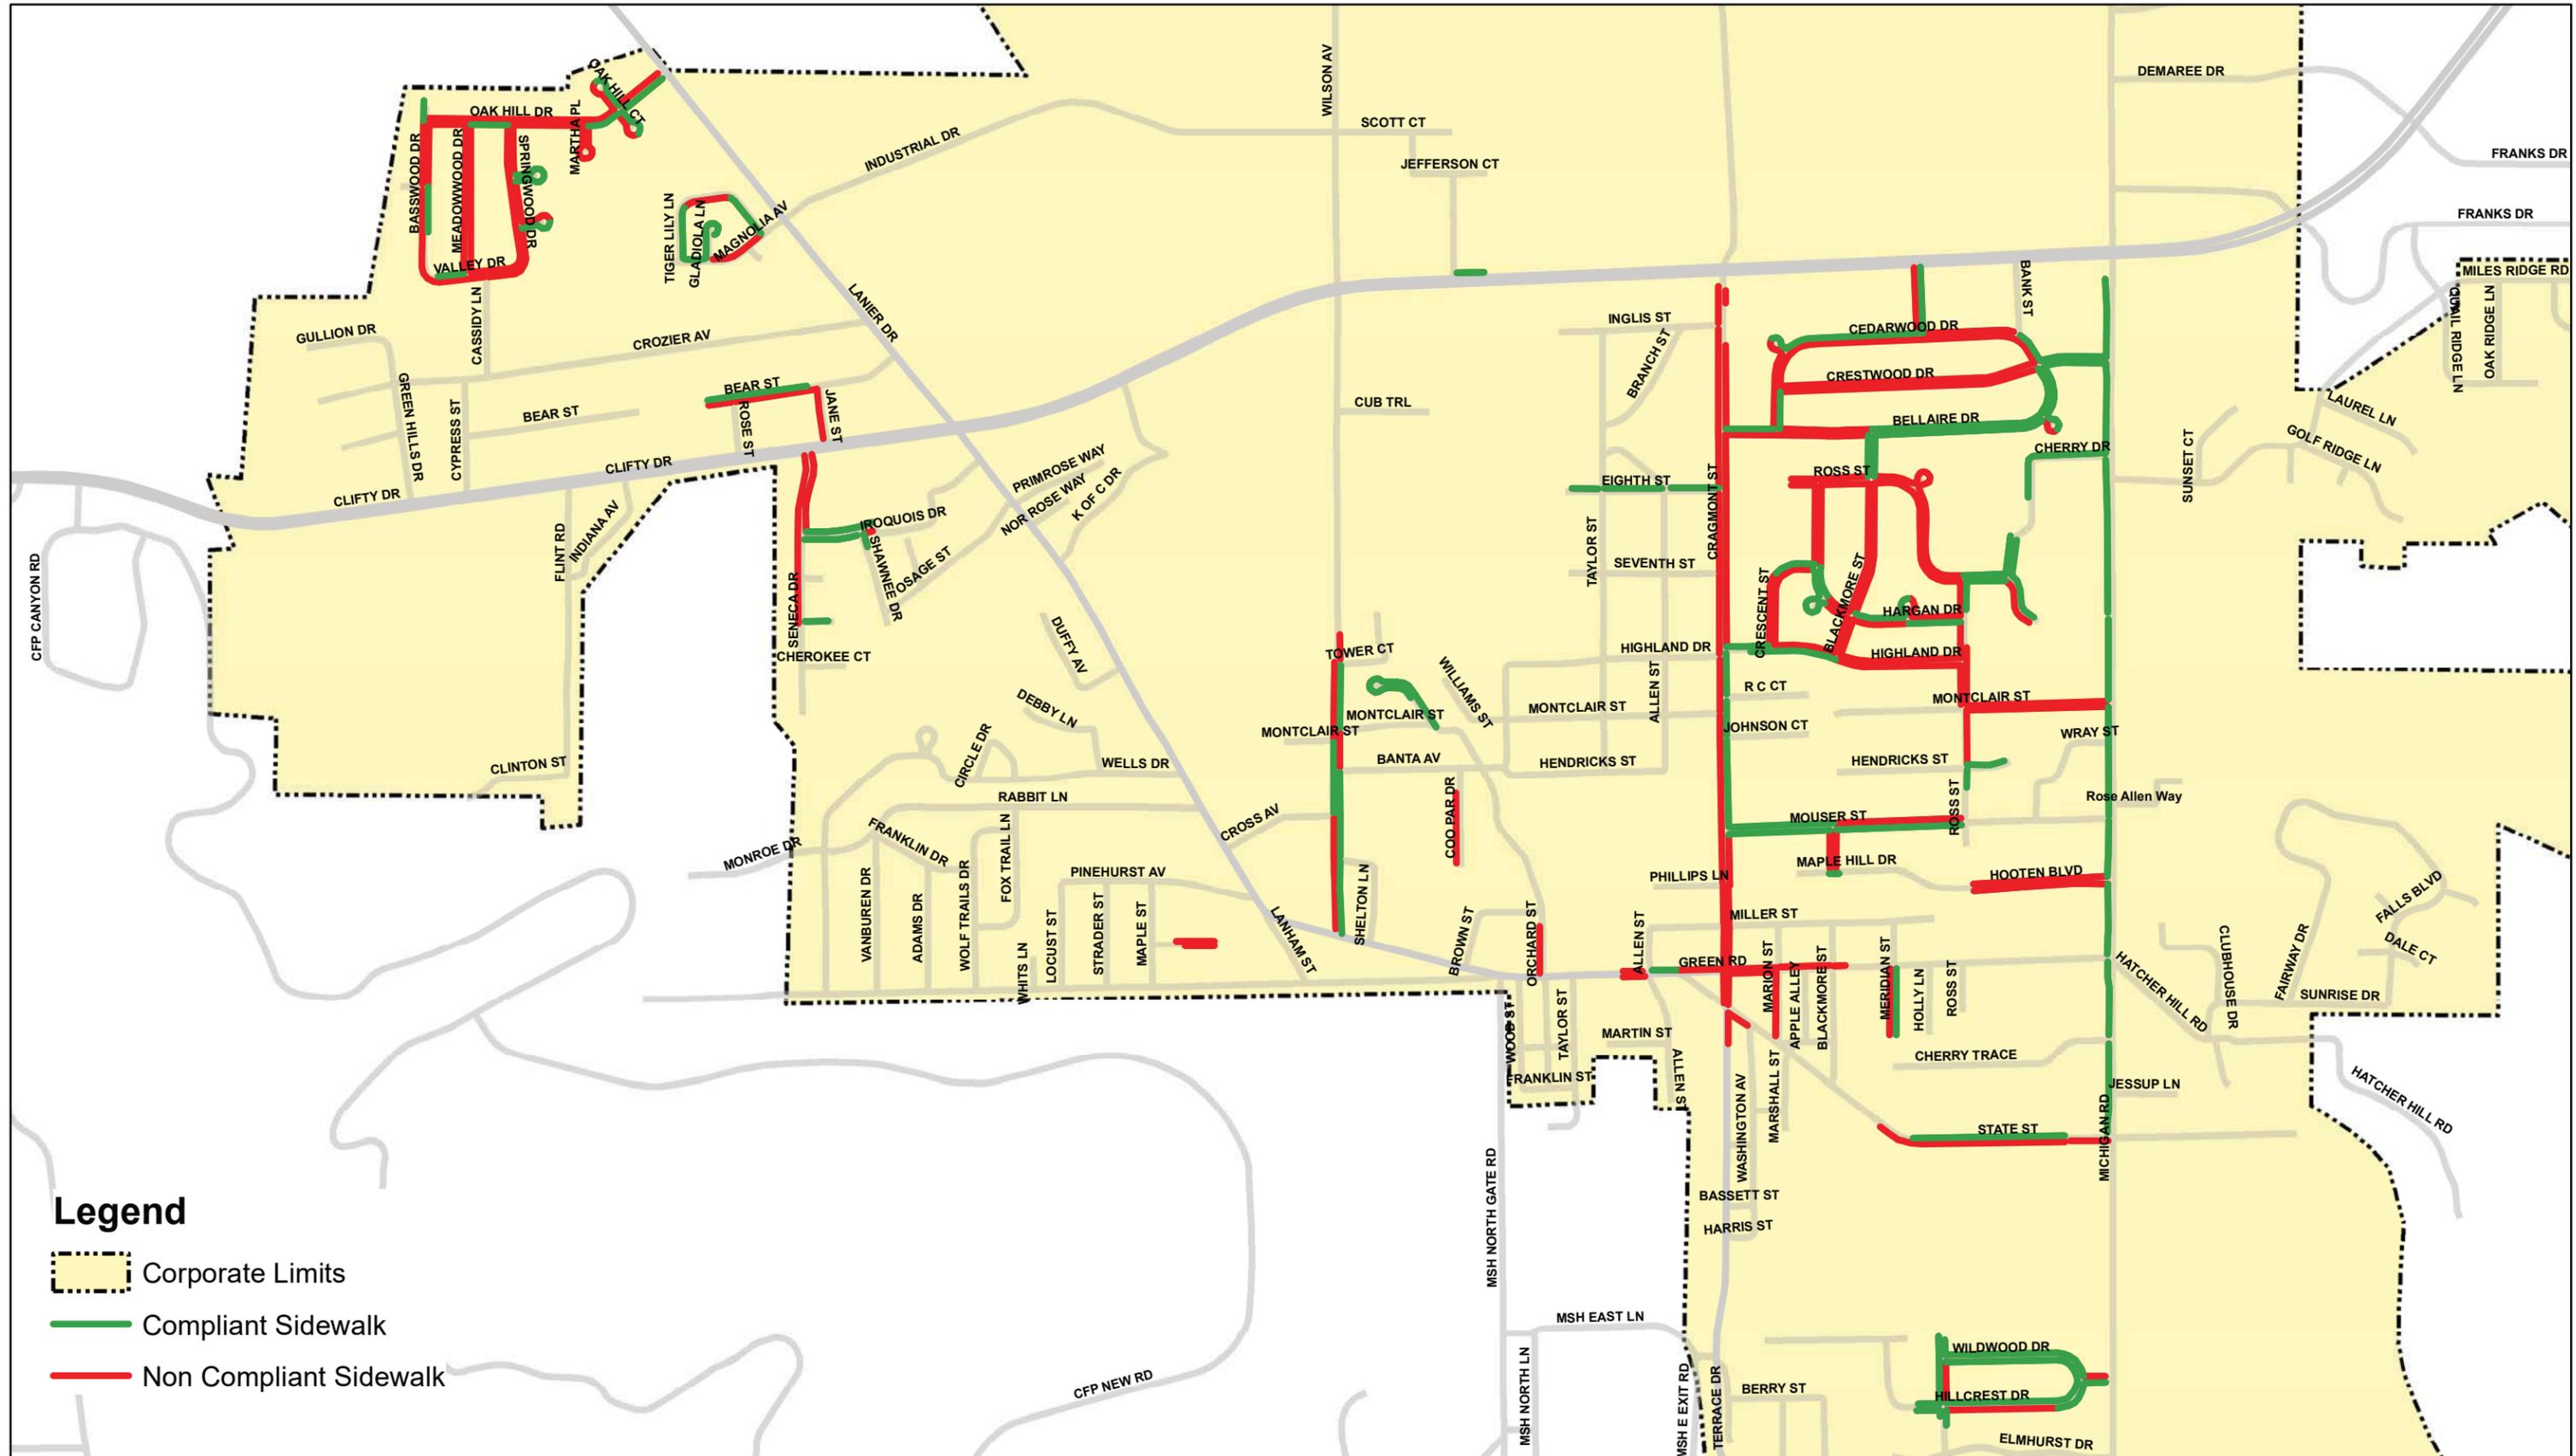
Sidewalk ADA Compliancy Map 1 of 2

The PASER Surface Rating maps found at the end of the section as Exhibit 1 illustrate the pavement condition data. The Sidewalk ADA Compliancy maps found at the end of the section as Exhibit 2 illustrate the Compliant and Non-Compliant sidewalk segments.

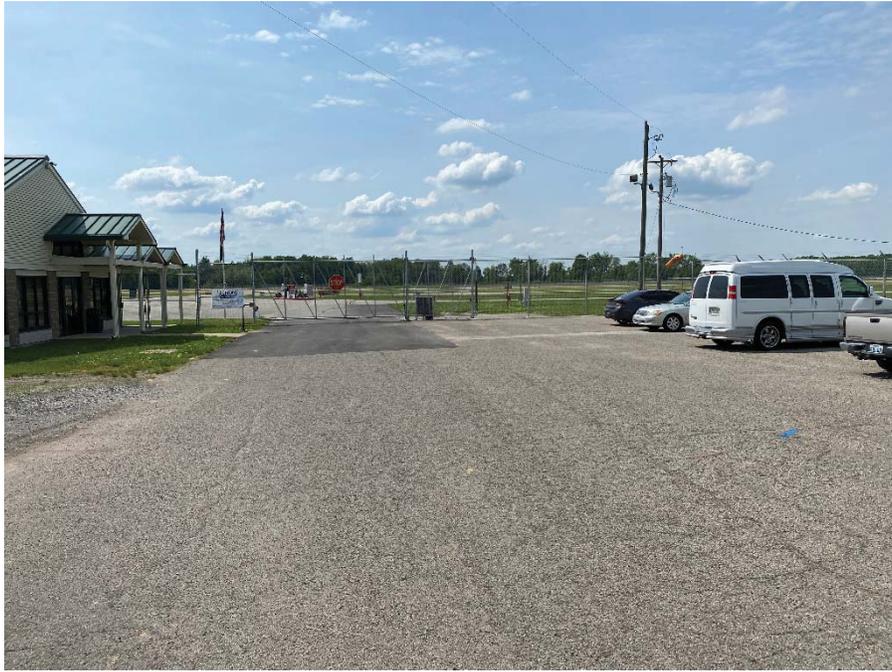
Airport Parking Lot

Airport - Parking Lot		
Stall Width	Measured	N/A
	ADA	96" MIN
Aisle Width	Measured	N/A
	ADA	96" MIN
Curb Ramp Width	Measured	72
	ADA	48" MIN
Curb Ramp Cross Slope	Measured	N/A
	ADA	2% MAX
Curb Ramp Running Slope	Measured	N/A
	ADA	8.33% MAX
Notes		No ADA parking stalls.

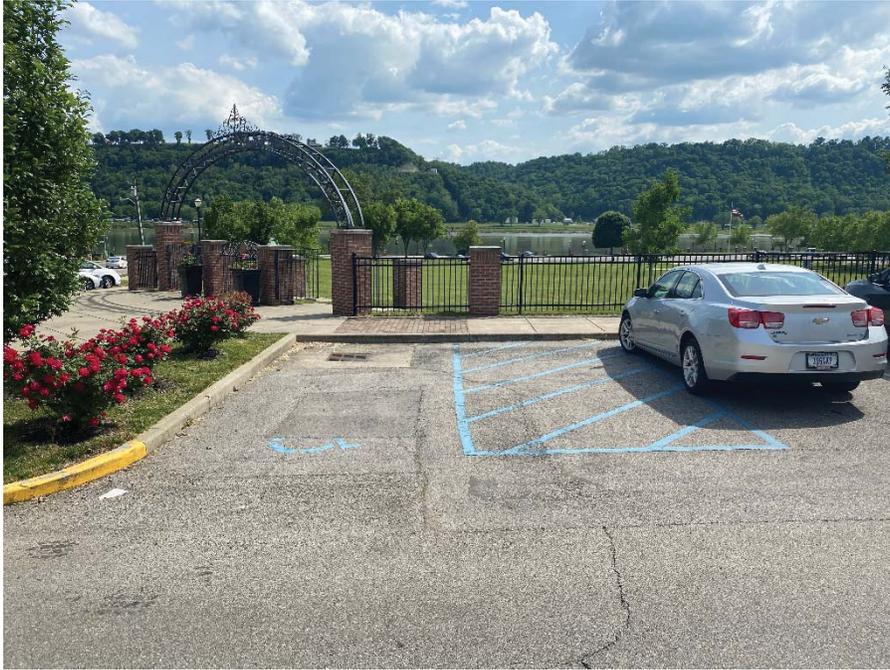
Bicentennial Park ADA Parking

Bicentennial Park - Parking Lot		
Stall Width	Measured	108"
	ADA	96" MIN
Aisle Width	Measured	108"
	ADA	96" MIN
Curb Ramp Width	Measured	N/A
	ADA	48" MIN
Curb Ramp Cross Slope	Measured	N/A
	ADA	2% MAX
Curb Ramp Running Slope	Measured	N/A
	ADA	8.33% MAX
Notes		No curb ramp at aisle. No ADA parking sign.

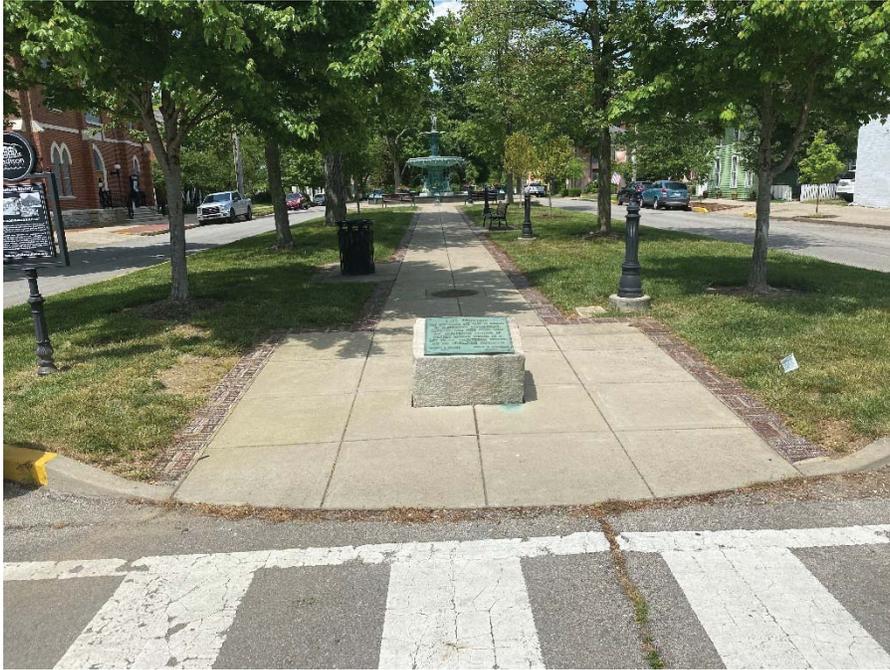
Broadway Fountain Entrance

Broadway Fountain - Parking Lot		
Stall Width	Measured	N/A
	ADA	96" MIN
Aisle Width	Measured	N/A
	ADA	96" MIN
Curb Ramp Width	Measured	66", 54"
	ADA	48" MIN
Curb Ramp Cross Slope	Measured	1.6%, 1.0%
	ADA	2% MAX
Curb Ramp Running Slope	Measured	7.5%, 2.3%
	ADA	8.33% MAX
Notes		Parallel Street parking only. No ADA parking.

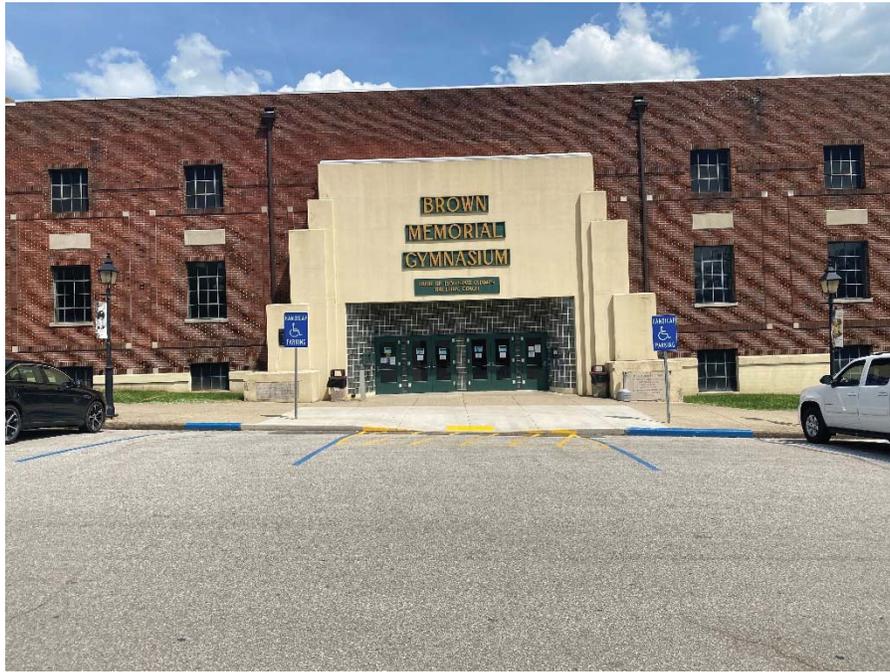
Brown Gymnasium Parking Area

Brown Gymnasium - Parking Lot		
Stall Width	Measured	158"
	ADA	96" MIN
Aisle Width	Measured	205"
	ADA	96" MIN
Curb Ramp Width	Measured	68"
	ADA	48" MIN
Curb Ramp Cross Slope	Measured	3.70%
	ADA	2% MAX
Curb Ramp Running Slope	Measured	7.20%
	ADA	8.33% MAX
Notes		2 ADA parking stalls.

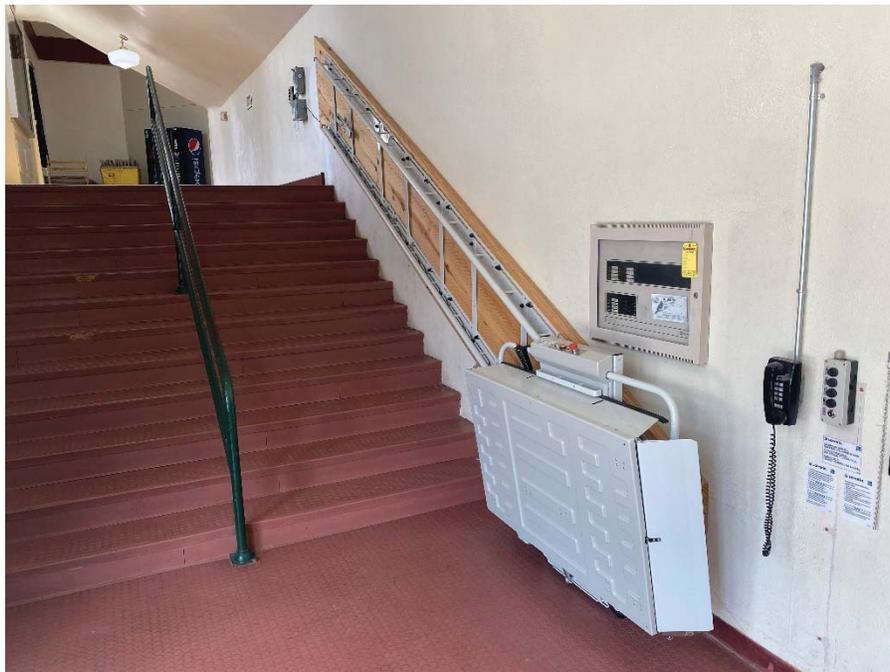
Brown Gymnasium Stairs and Chair Lift

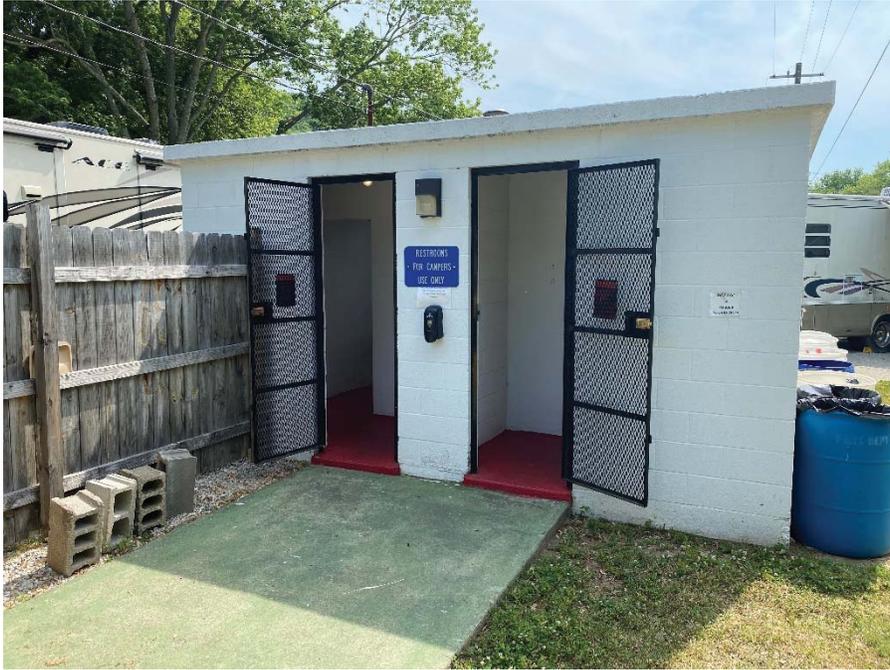
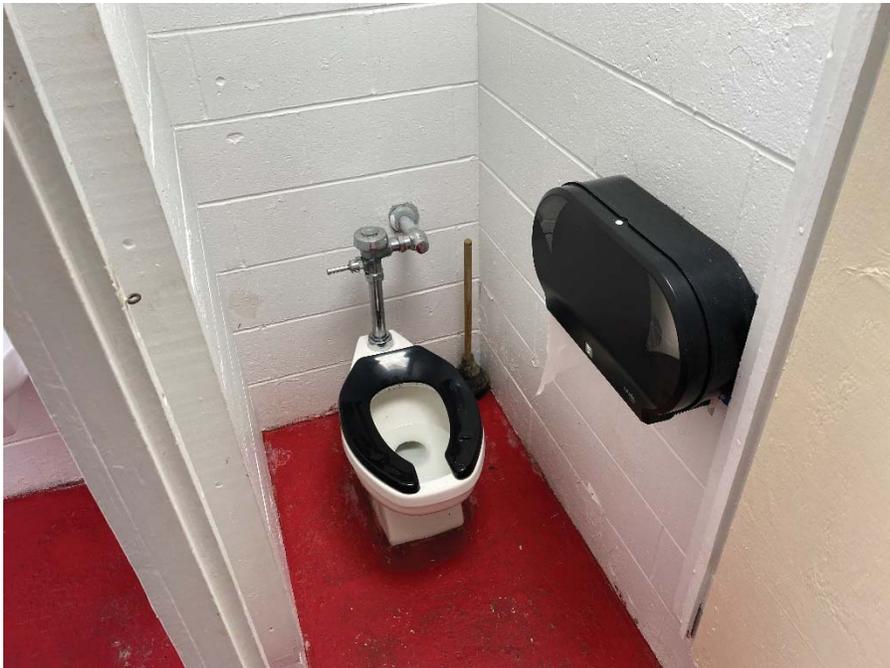
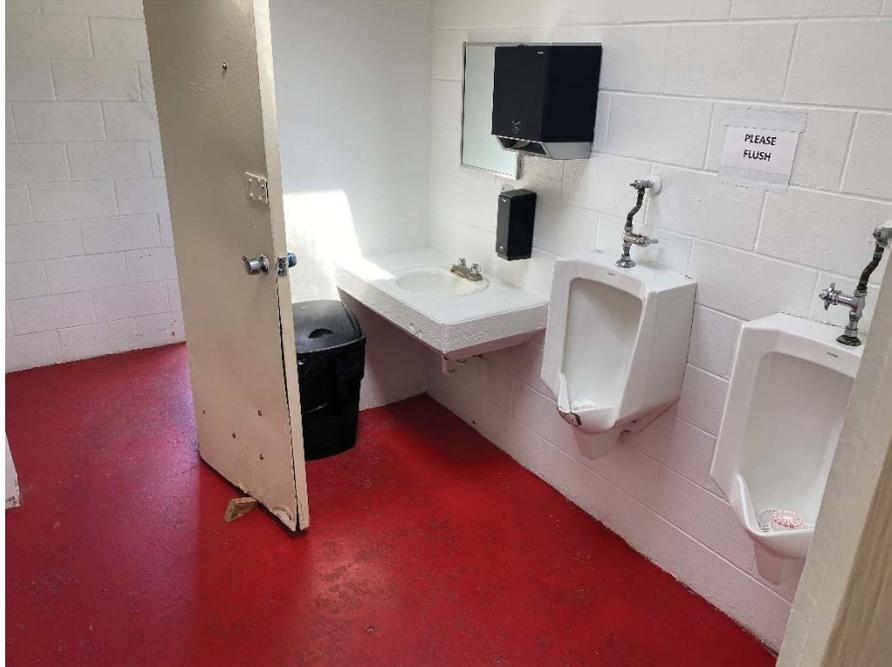
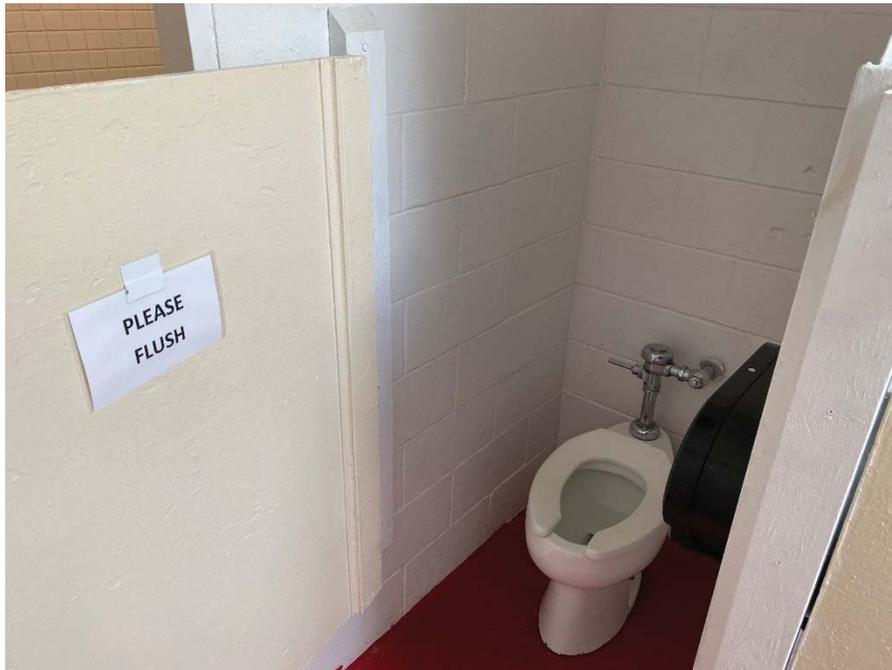
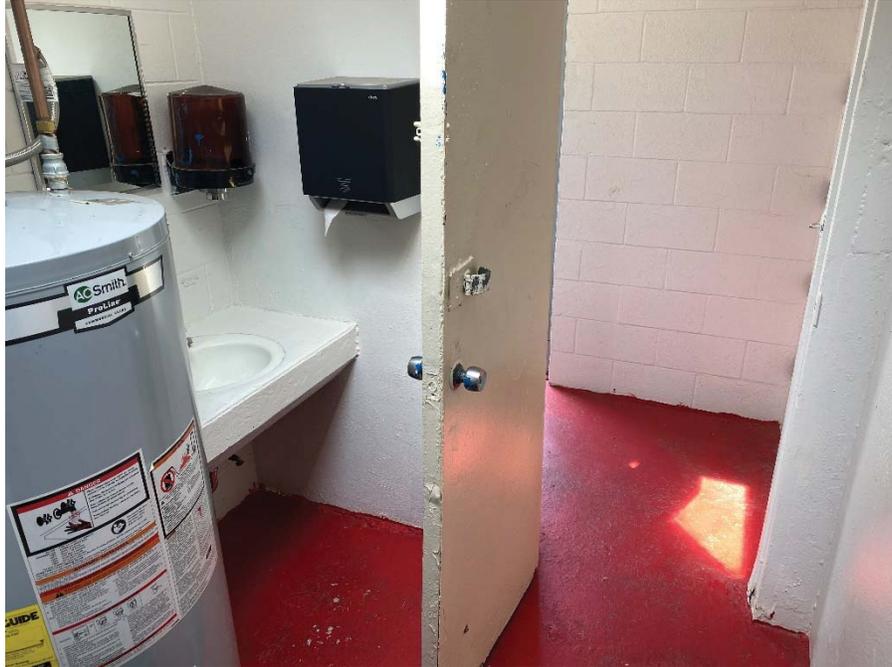
Campground Restrooms

Men's Stall

Men's Restroom

Women's Stall

Women's Restroom

Campground - Restrooms			
		Men	Women
Door Opening	Measured	26"	25"
	ADA	32" MIN	
Stall Door	Measured	28"	30"
	ADA	32" MIN	
Stall/Bathroom Dimensions	Measured	45" X 30"	38" X 32"
	ADA	56" DEEP X 60" WIDE	
Grab Bars	Y/N	N	N
Grab Bar Height	Measured	N/A	N/A
	ADA	33" - 36"	
Urinals	Y/N	Y	N/A
Urinal Height	Measured	24"	N/A
	ADA	17" MAX	
Toilet Seat Height	Measured	16"	19"
	ADA	17" - 19"	
Counter/Sink Height	Measured	33"	33"
	ADA	34" MAX	
Towel/Dryer	Measured	56", 12"	50", 0"
	ADA	48" MAX HEIGHT, 20" MAX DEPTH	
Soap	Measured	39", 16"	39", 16"
	ADA	48" MAX HEIGHT, 20" MAX DEPTH	
Notes

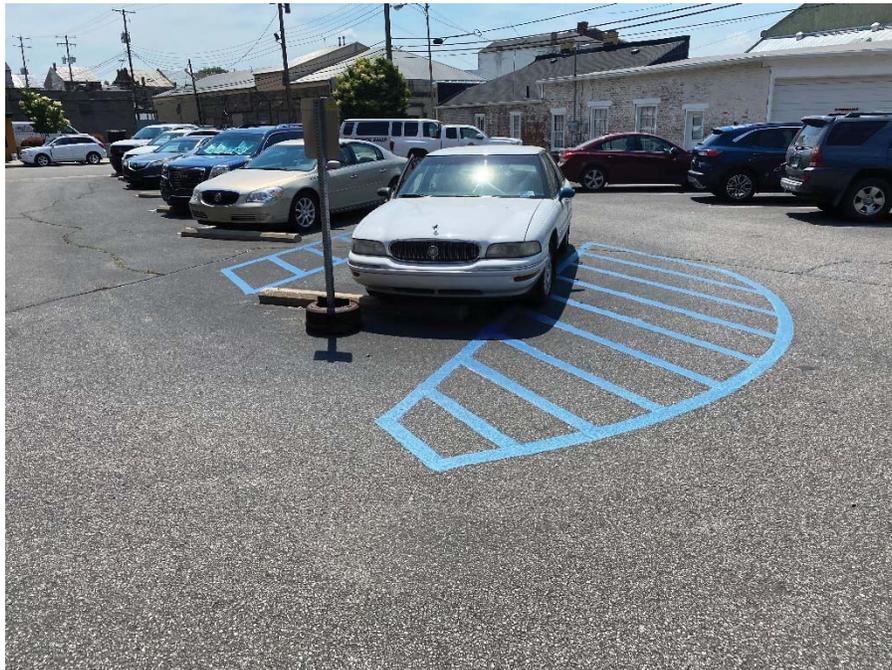
City Hall Parking Lot

City Hall - Parking Lot		
Stall Width	Measured	110"
	ADA	96" MIN
Aisle Width	Measured	64" ***
	ADA	96" MIN
Curb Ramp Width	Measured	N/A
	ADA	48" MIN
Curb Ramp Cross Slope	Measured	N/A
	ADA	2% MAX
Curb Ramp Running Slope	Measured	N/A
	ADA	8.33% MAX
Notes		1 ADA parking stall located in the middle of the rear City Hall parking lot. No ADA parking sign. ADA entry to building is around the front. ***There appears to be enough space to apply ADA compliant pavement markings.

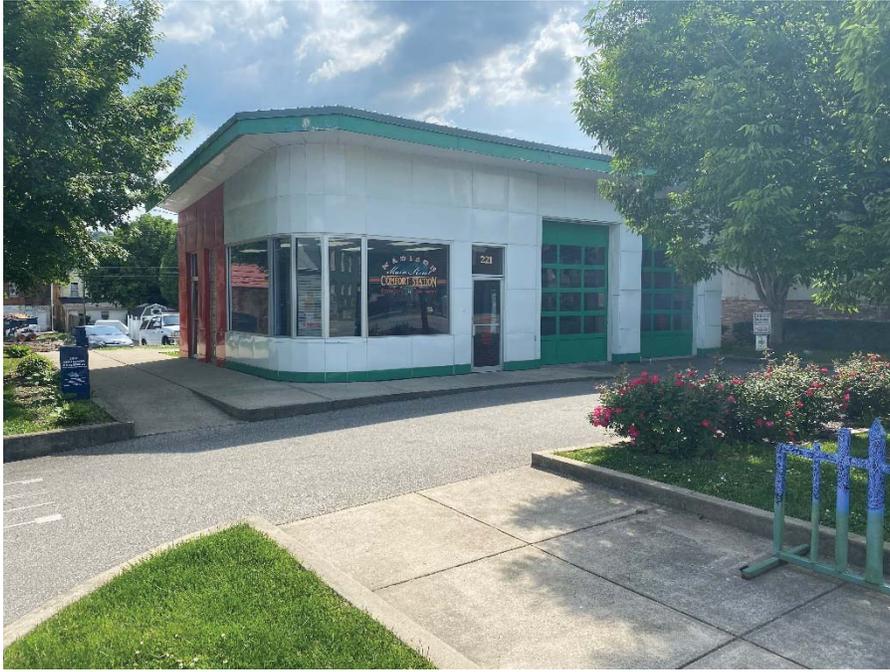
Comfort Station ADA Parking

Comfort Station - Parking Lot		
Stall Width	Measured	N/A
	ADA	96" MIN
Aisle Width	Measured	N/A
	ADA	96" MIN
Curb Ramp Width	Measured	59"
	ADA	48" MIN
Curb Ramp Cross Slope	Measured	1.20%
	ADA	2% MAX
Curb Ramp Running Slope	Measured	7.50%
	ADA	8.33% MAX
Notes		ADA parking is a 16' lane for temporary parking in front of facility.

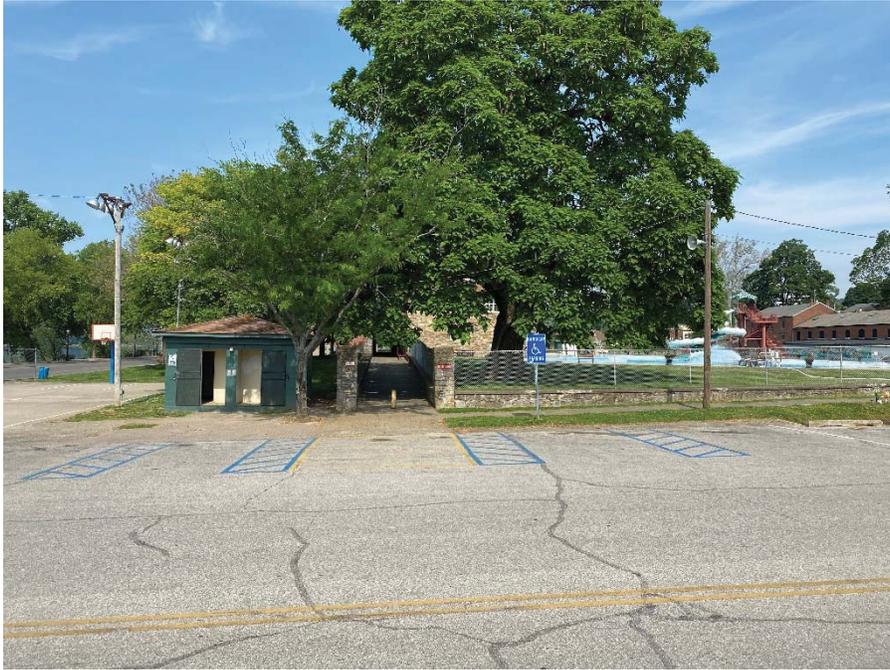
Crystal Beach Parking Area

Crystal Beach - Parking Lot		
Stall Width	Measured	96", 120"
	ADA	96" MIN
Aisle Width	Measured	250"
	ADA	96" MIN
Curb Ramp Width	Measured	N/A
	ADA	48" MIN
Curb Ramp Cross Slope	Measured	N/A
	ADA	2% MAX
Curb Ramp Running Slope	Measured	N/A
	ADA	8.33% MAX
Notes		Two ADA parking stalls, but only 1 sign. Sidewalk is flush with street at aisle.

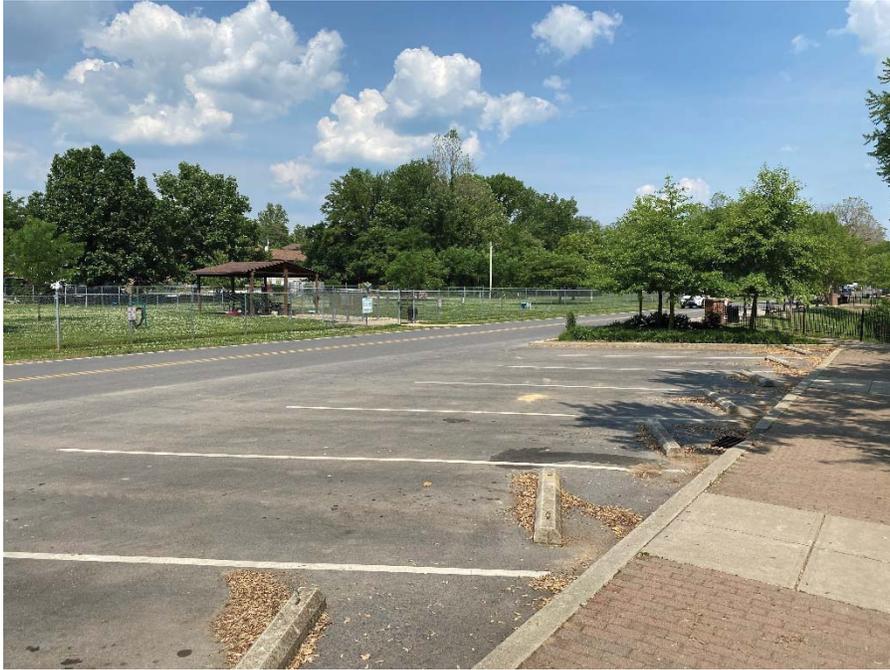
Dog Park Entrance and Parking Area

Dog Park - Parking Lot		
Stall Width	Measured	N/A
	ADA	96" MIN
Aisle Width	Measured	N/A
	ADA	96" MIN
Curb Ramp Width	Measured	N/A
	ADA	48" MIN
Curb Ramp Cross Slope	Measured	N/A
	ADA	2% MAX
Curb Ramp Running Slope	Measured	N/A
	ADA	8.33% MAX
Notes		No ADA Parking. No ramp at sidewalk.

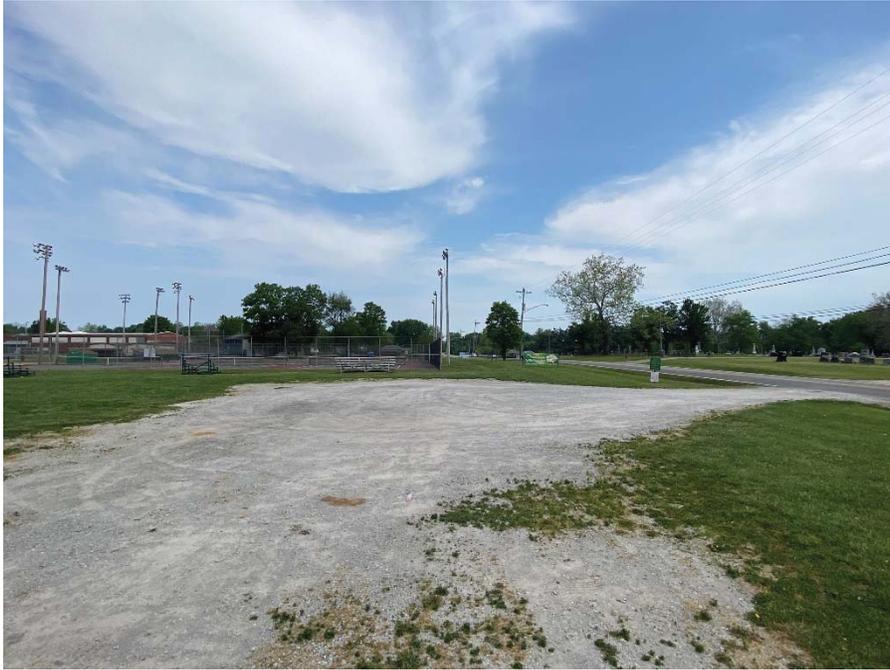
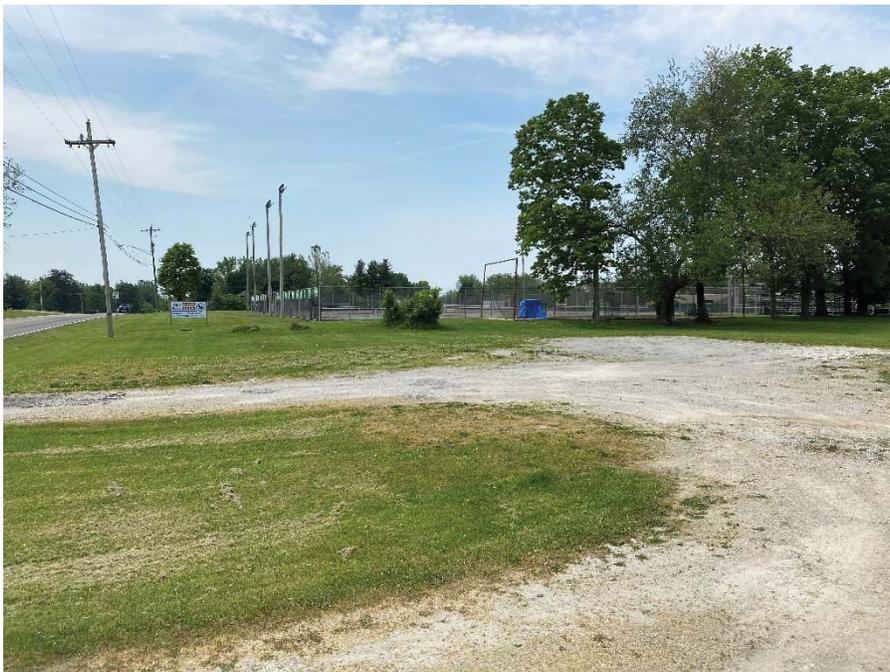
Dr. Stucker Tennis Courts - Parking Lots		
Stall Width	Measured	N/A
	ADA	96" MIN
Aisle Width	Measured	N/A
	ADA	96" MIN
Curb Ramp Width	Measured	N/A
	ADA	48" MIN
Curb Ramp Cross Slope	Measured	N/A
	ADA	2% MAX
Curb Ramp Running Slope	Measured	N/A
	ADA	8.33% MAX
Notes		Gravel Parking lot. No ADA Parking. No sidewalk to facility.

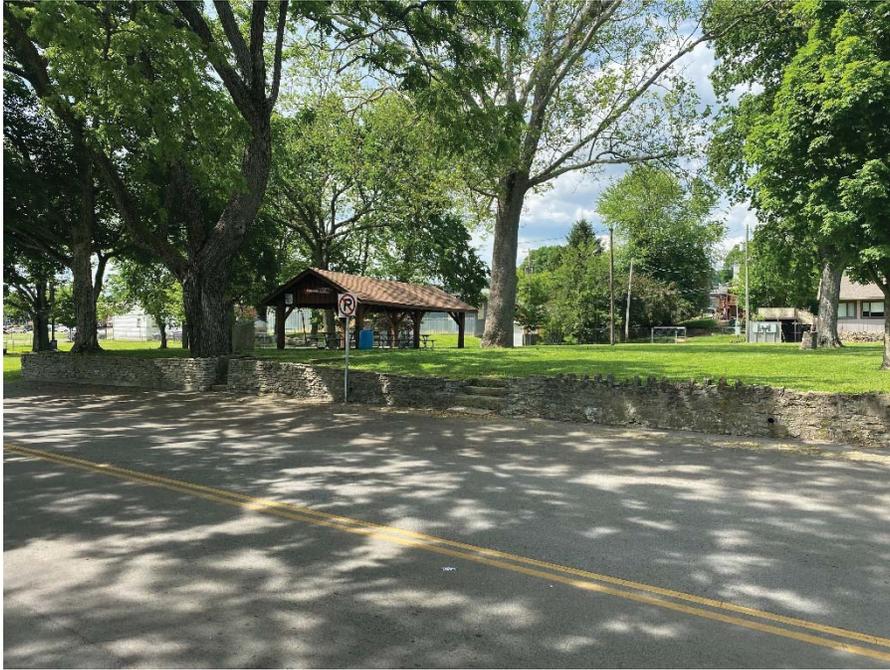
Fireman's Park Entrance

Fireman's Park - Parking Lot		
Stall Width	Measured	N/A
	ADA	96" MIN
Aisle Width	Measured	N/A
	ADA	96" MIN
Curb Ramp Width	Measured	N/A
	ADA	48" MIN
Curb Ramp Cross Slope	Measured	N/A
	ADA	2% MAX
Curb Ramp Running Slope	Measured	N/A
	ADA	8.33% MAX
Notes		Street parking only. No ADA parking stalls. No ramp up to park. No sidewalk to facility.

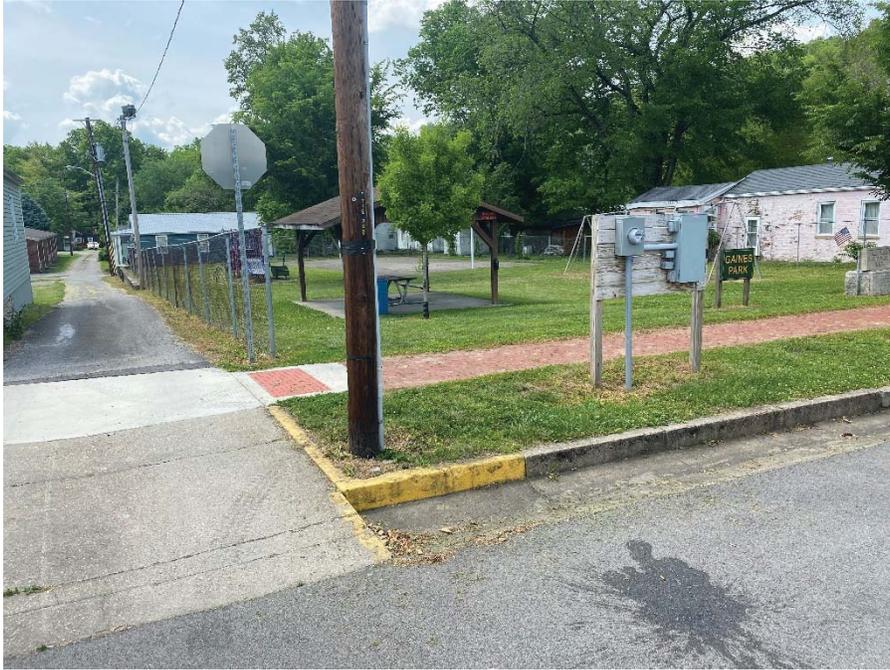
Gaines Park Entrance

Gaines Park - Parking Lot		
Stall Width	Measured	N/A
	ADA	96" MIN
Aisle Width	Measured	N/A
	ADA	96" MIN
Curb Ramp Width	Measured	63"
	ADA	48" MIN
Curb Ramp Cross Slope	Measured	1.00%
	ADA	2% MAX
Curb Ramp Running Slope	Measured	2.40%
	ADA	8.33% MAX
Notes		No ADA parking. No sidewalk to facilities.

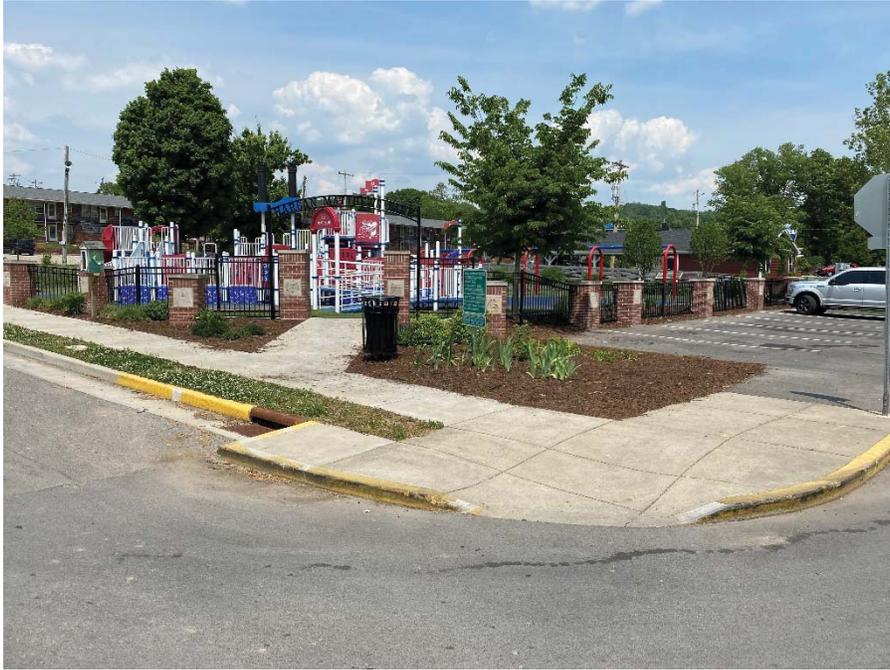
Hargan-Matthews Entrance and Parking Area

Hargan-Matthews Park - Parking Lot		
Stall Width	Measured	N/A
	ADA	96" MIN
Aisle Width	Measured	N/A
	ADA	96" MIN
Curb Ramp Width	Measured	N/A
	ADA	48" MIN
Curb Ramp Cross Slope	Measured	N/A
	ADA	2% MAX
Curb Ramp Running Slope	Measured	N/A
	ADA	8.33% MAX
Notes		No ADA parking stalls. Sidewalk flush with parking area. Park facilities appear ADA compliant for users.

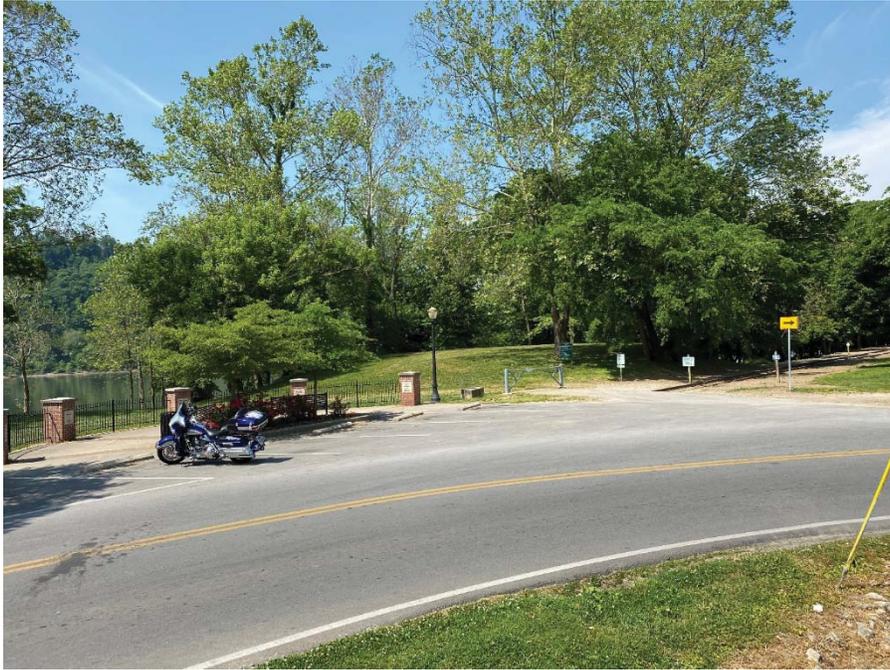
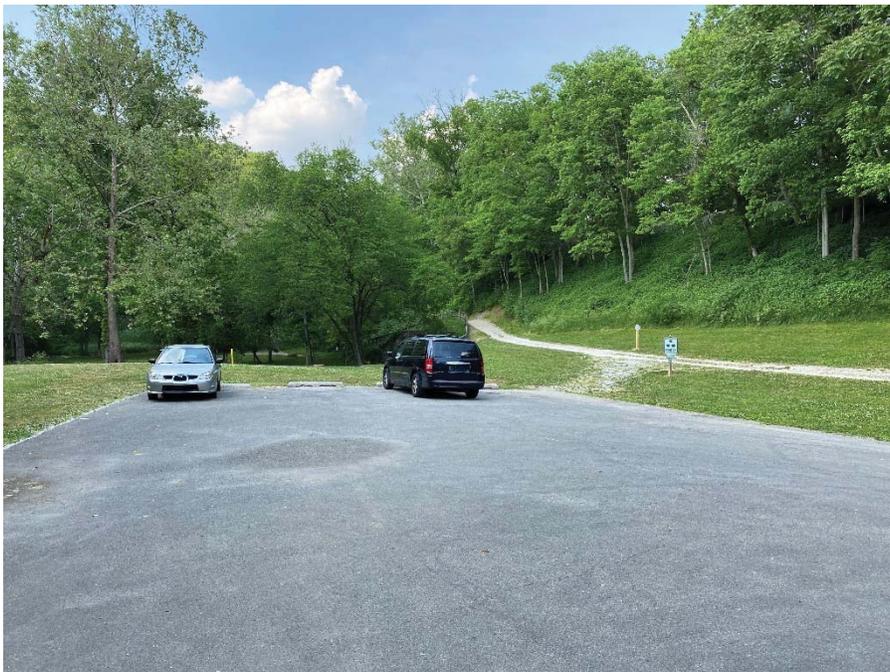
Heritage Trail - Parking Lots		
Stall Width	Measured	N/A
	ADA	96" MIN
Aisle Width	Measured	N/A
	ADA	96" MIN
Curb Ramp Width	Measured	N/A
	ADA	48" MIN
Curb Ramp Cross Slope	Measured	N/A
	ADA	2% MAX
Curb Ramp Running Slope	Measured	N/A
	ADA	8.33% MAX
Notes		No ADA parking stalls. Trail is gravel and not ADA compliant.

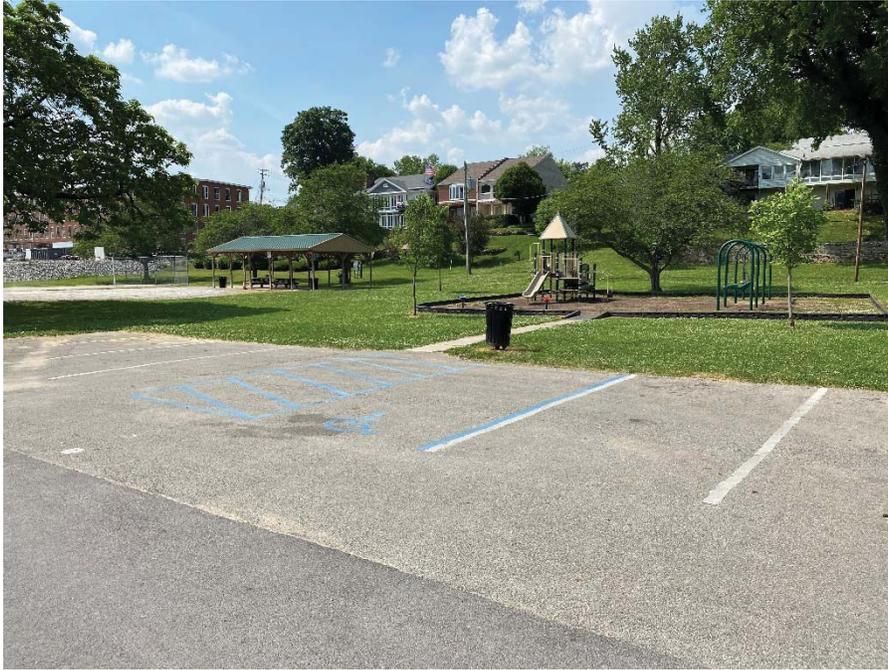
Jaycee Park Entrance and Parking Lot

Jaycee Park - Parking Lot		
Stall Width	Measured	104"
	ADA	96" MIN
Aisle Width	Measured	104"
	ADA	96" MIN
Curb Ramp Width	Measured	N/A
	ADA	48" MIN
Curb Ramp Cross Slope	Measured	N/A
	ADA	2% MAX
Curb Ramp Running Slope	Measured	N/A
	ADA	8.33% MAX
Notes		Sidewalk is flush with street at aisle.

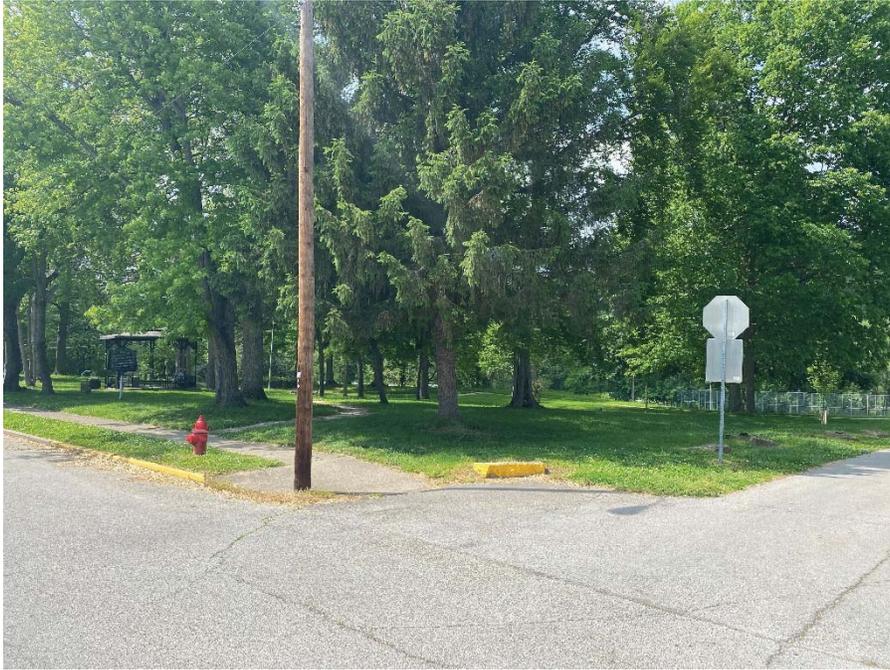
John Paul Park Entrance

John Paul Park - Parking Lot		
Stall Width	Measured	N/A
	ADA	96" MIN
Aisle Width	Measured	N/A
	ADA	96" MIN
Curb Ramp Width	Measured	N/A
	ADA	48" MIN
Curb Ramp Cross Slope	Measured	N/A
	ADA	2% MAX
Curb Ramp Running Slope	Measured	N/A
	ADA	8.33% MAX
Notes		Parallel street parking only. No ADA parking stalls.
