**AMERICANS WITH DISABILITIES
ACT (ADA) TRANSITION PLAN FOR
PUBLIC FACILITIES and SIDEWALK
ASSET MANAGEMENT PLAN**

**Madison City Hall
101 West Main Street
Madison, IN 47250**

September 7, 2021

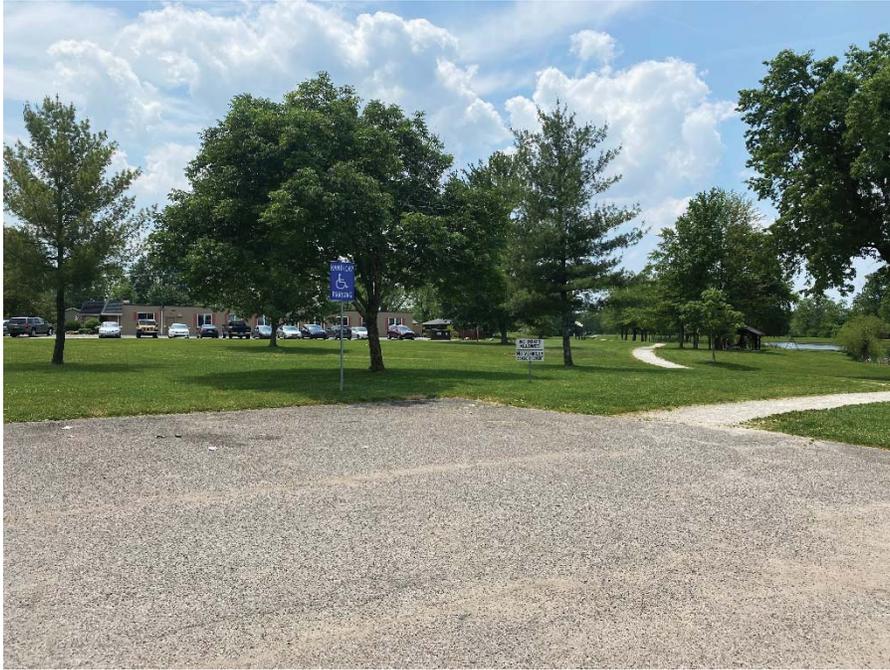
Johnson Lake Park Entrance and Parking Lot

Johnson Lake Park - Parking Lot		
Stall Width	Measured	N/A
	ADA	96" MIN
Aisle Width	Measured	N/A
	ADA	96" MIN
Curb Ramp Width	Measured	N/A
	ADA	48" MIN
Curb Ramp Cross Slope	Measured	N/A
	ADA	2% MAX
Curb Ramp Running Slope	Measured	N/A
	ADA	8.33% MAX
Notes		1 ADA parking sign. No pavement markings. Gravel path to lake.

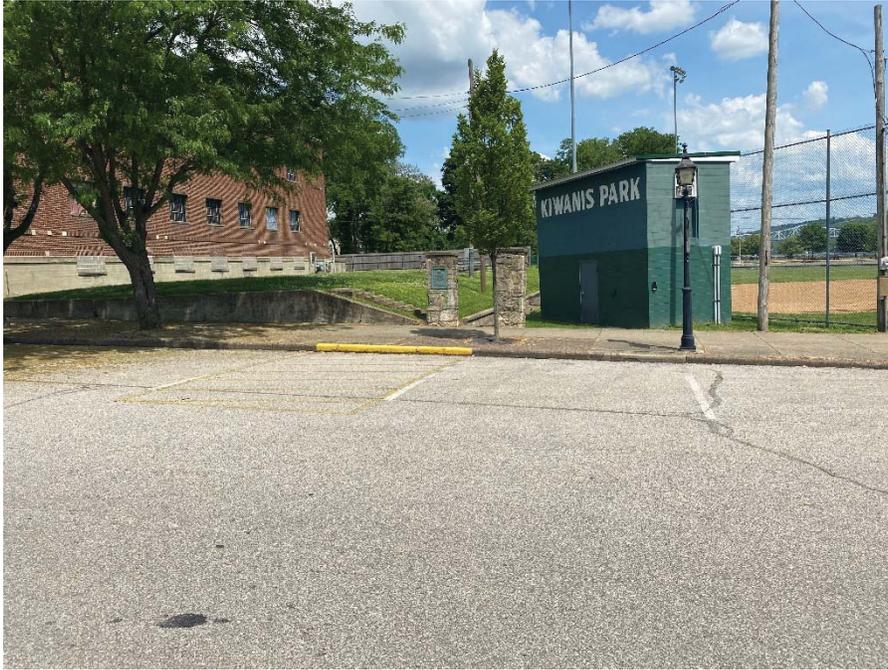
Kiwanis Park ADA Parking

Kiwanis Park - Parking Lot		
Stall Width	Measured	164", 148"
	ADA	96" MIN
Aisle Width	Measured	144"
	ADA	96" MIN
Curb Ramp Width	Measured	N/A
	ADA	48" MIN
Curb Ramp Cross Slope	Measured	N/A
	ADA	2% MAX
Curb Ramp Running Slope	Measured	N/A
	ADA	8.33% MAX
Notes		2 ADA parking stalls. No ADA parking signs. No curb ramp onto sidewalk.

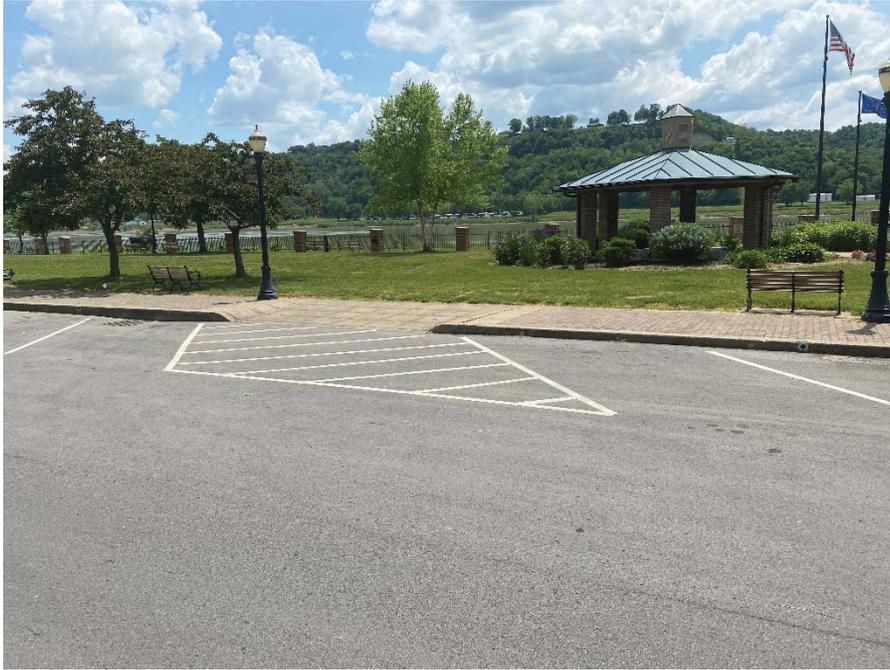
Lamplighter Park Entrance and Parking Area

Lamplighter Park - Parking Lot		
Stall Width	Measured	102"
	ADA	96" MIN
Aisle Width	Measured	N/A
	ADA	96" MIN
Curb Ramp Width	Measured	108"
	ADA	48" MIN
Curb Ramp Cross Slope	Measured	2.80%
	ADA	2% MAX
Curb Ramp Running Slope	Measured	15%+
	ADA	8.33% MAX
Notes		No ADA parking stalls. No pavement markings for aisle but there appears to be enough width for aisle.

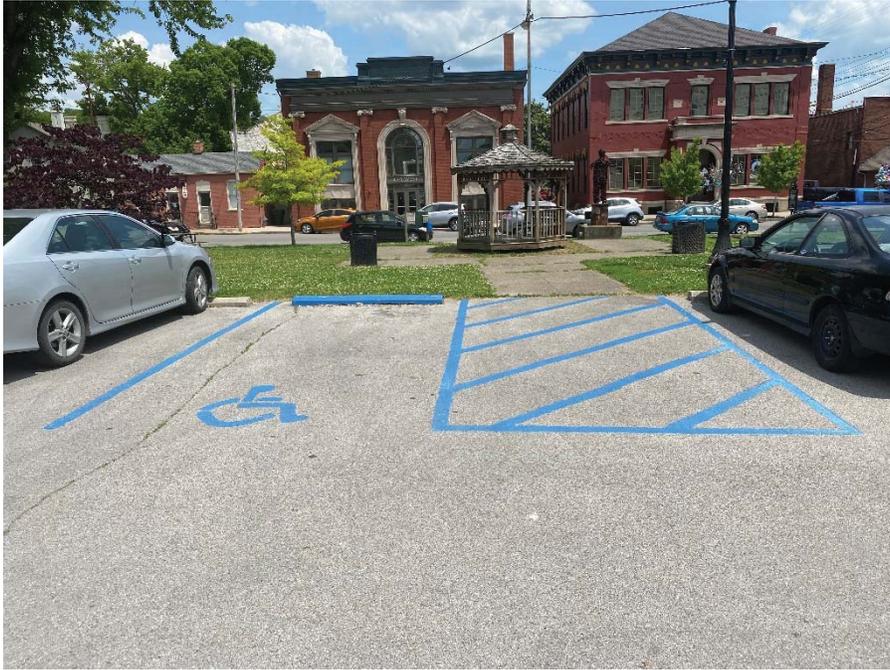
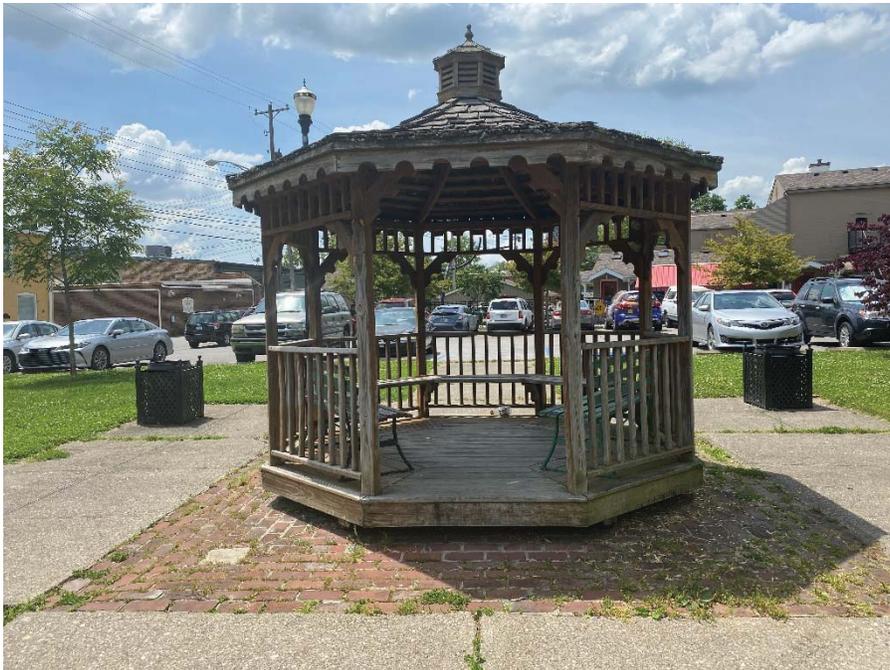
Lytle Park - Parking Lot		
Stall Width	Measured	104"
	ADA	96" MIN
Aisle Width	Measured	104"
	ADA	96" MIN
Curb Ramp Width	Measured	86"
	ADA	48" MIN
Curb Ramp Cross Slope	Measured	1.20%
	ADA	2% MAX
Curb Ramp Running Slope	Measured	1.20%
	ADA	8.33% MAX
Notes		No ADA parking sign. No ramp into gazebo.

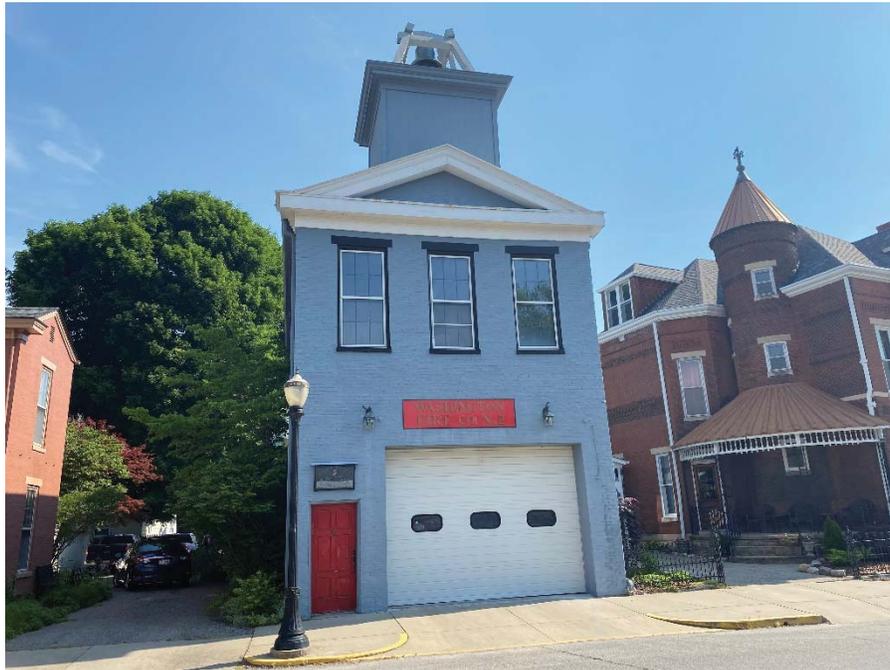
No. 2 Firehouse Entrance

No. 2 Firehouse - Building		
Ramp Running Slope	Measured	N/A
	ADA	8.33% MAX
Ramp Cross Slope	Measured	N/A
	ADA	2% MAX
Ramp Width	Measured	N/A
	ADA	48" MIN
Ramp Handrails	Y/N	N/A
Handrail Height	Measured	N/A
	ADA	34" - 38"
Front Door	Measured	29"
	ADA	32" MIN
Fountain Spout Outlet Height	Measured	N/A
	ADA	36" MAX
Hallway Door Width	Measured	N/A
	ADA	32" MIN
Notes		Building not open to public.

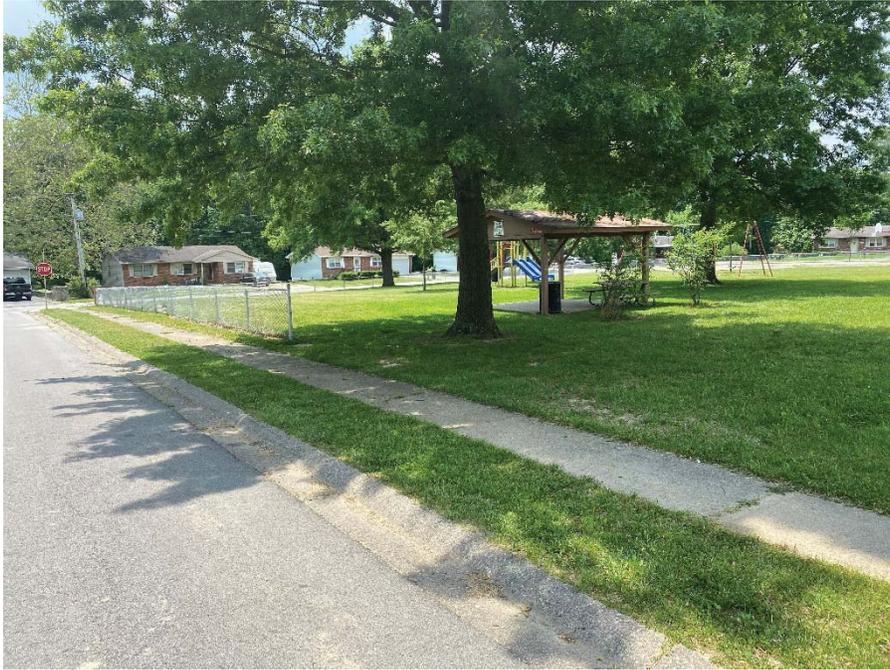
Oak Hill Park Entrance

Oak Hill Park - Parking Lot		
Stall Width	Measured	N/A
	ADA	96" MIN
Aisle Width	Measured	N/A
	ADA	96" MIN
Curb Ramp Width	Measured	N/A
	ADA	48" MIN
Curb Ramp Cross Slope	Measured	N/A
	ADA	2% MAX
Curb Ramp Running Slope	Measured	N/A
	ADA	8.33% MAX
Notes		Parallel street parking only. No ADA stalls. No ramp onto sidewalk. No sidewalk into park.

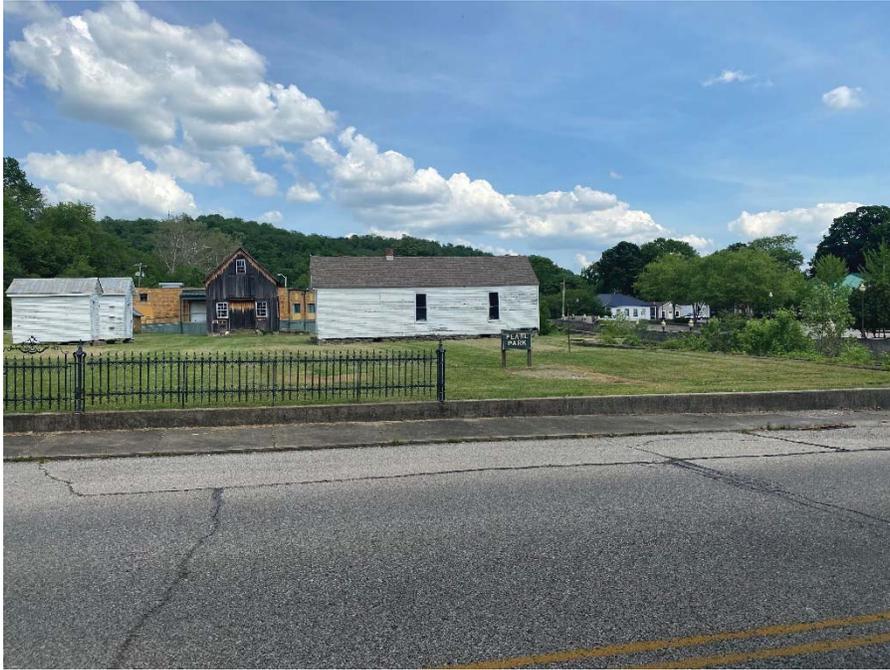
Pearl Park Entrance

Pearl Park - Parking Lot		
Stall Width	Measured	N/A
	ADA	96" MIN
Aisle Width	Measured	N/A
	ADA	96" MIN
Curb Ramp Width	Measured	N/A
	ADA	48" MIN
Curb Ramp Cross Slope	Measured	N/A
	ADA	2% MAX
Curb Ramp Running Slope	Measured	N/A
	ADA	8.33% MAX
Notes		Parallel street parking only. No ADA parking stalls.

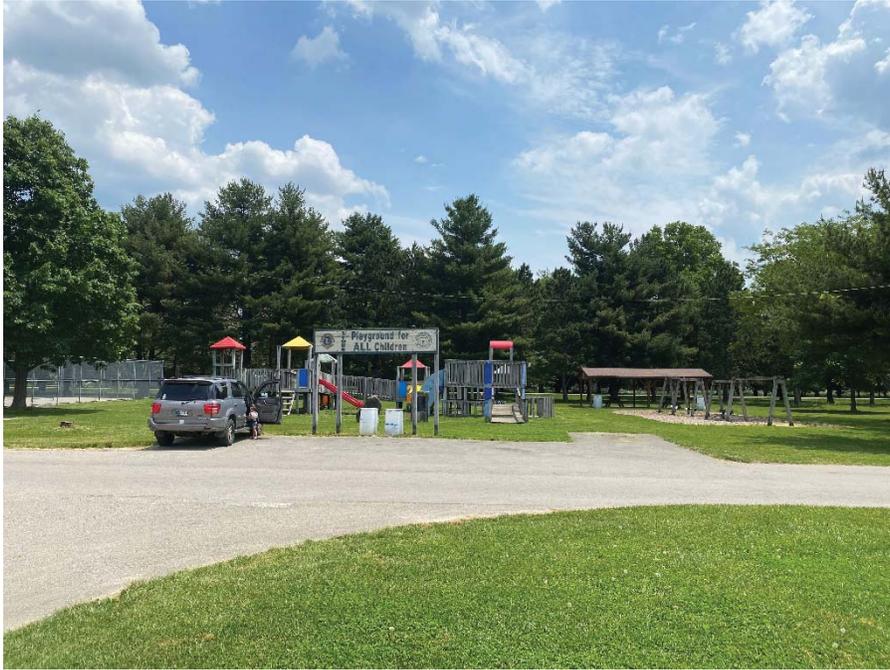
Playground For All Children Entrance and Parking Area

Playground For All Children - Parking Lot		
Stall Width	Measured	N/A
	ADA	96" MIN
Aisle Width	Measured	N/A
	ADA	96" MIN
Curb Ramp Width	Measured	N/A
	ADA	48" MIN
Curb Ramp Cross Slope	Measured	N/A
	ADA	2% MAX
Curb Ramp Running Slope	Measured	N/A
	ADA	8.33% MAX
Notes		No ADA parking stalls. No sidewalks to facilities.

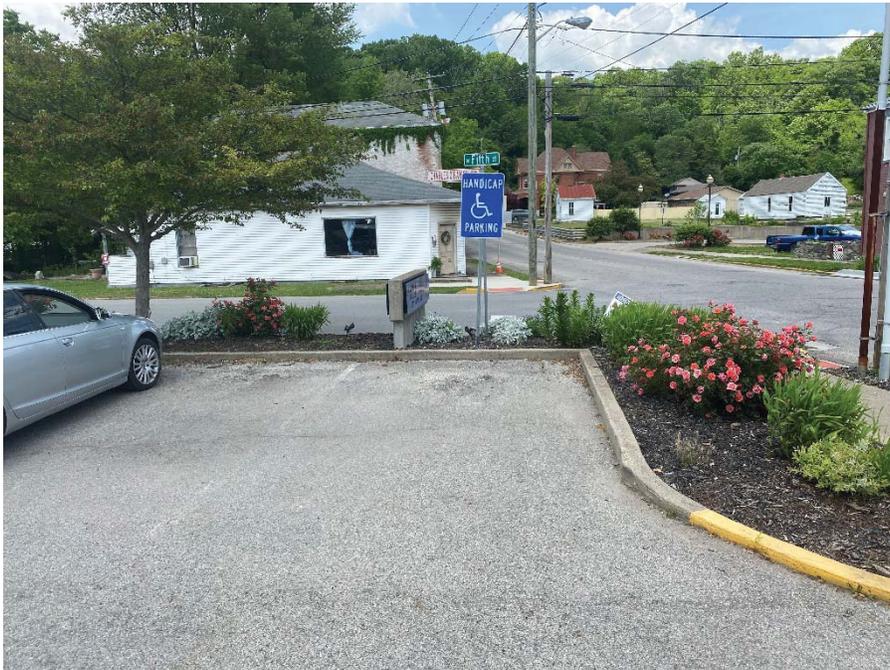
Police Station ADA Parking

Police Station - Parking Lot		
Stall Width	Measured	115"
	ADA	96" MIN
Aisle Width	Measured	N/A
	ADA	96" MIN
Curb Ramp Width	Measured	108"
	ADA	48" MIN
Curb Ramp Cross Slope	Measured	3.10%
	ADA	2% MAX
Curb Ramp Running Slope	Measured	16.70%
	ADA	8.33% MAX
Notes		No ADA aisle. Ramp from parking to front door is part of the sidewalk for street.

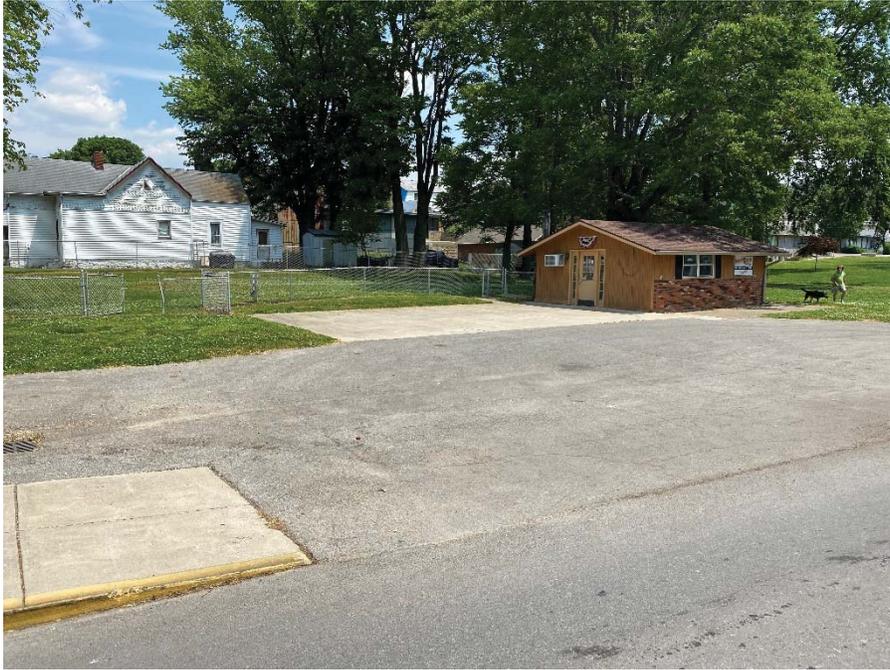
Regatta Office Parking Lot

Regatta Office - Parking Lot		
Stall Width	Measured	N/A
	ADA	96" MIN
Aisle Width	Measured	N/A
	ADA	96" MIN
Curb Ramp Width	Measured	N/A
	ADA	48" MIN
Curb Ramp Cross Slope	Measured	N/A
	ADA	2% MAX
Curb Ramp Running Slope	Measured	N/A
	ADA	8.33% MAX
Notes		No ADA stalls. Parking area flush with building.

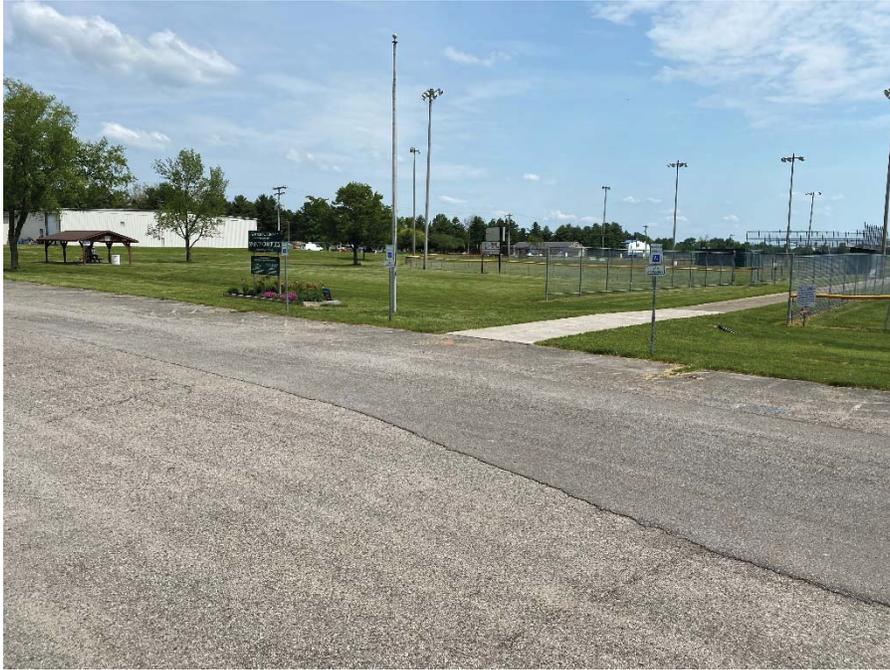
Rucker Sports Complex Parking Lot

Rucker Sports Complex - Parking Lot		
Stall Width	Measured	96"
	ADA	96" MIN
Aisle Width	Measured	96"
	ADA	96" MIN
Curb Ramp Width	Measured	N/A
	ADA	48" MIN
Curb Ramp Cross Slope	Measured	N/A
	ADA	2% MAX
Curb Ramp Running Slope	Measured	N/A
	ADA	8.33% MAX
Notes		4 ADA parking stalls. Signs don't align with stalls. Sidewalk flush with parking area.

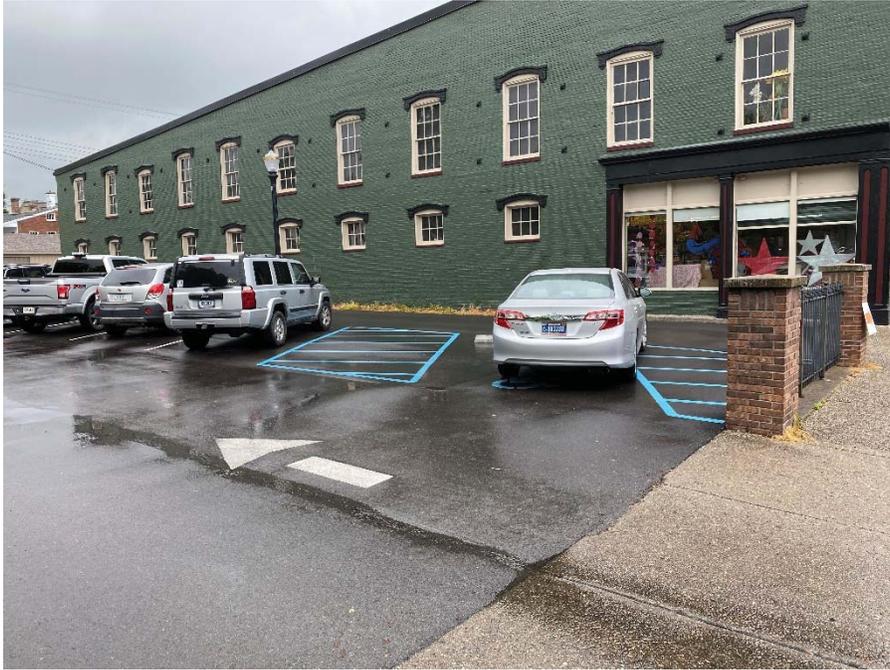
Senior Citizens' Center Parking Area

Senior Citizens' Center - Parking Lot		
Stall Width	Measured	116"
	ADA	96" MIN
Aisle Width	Measured	112"
	ADA	96" MIN
Curb Ramp Width	Measured	N/A
	ADA	48" MIN
Curb Ramp Cross Slope	Measured	N/A
	ADA	2% MAX
Curb Ramp Running Slope	Measured	N/A
	ADA	8.33% MAX
Notes		2 ADA stalls located in shared City parking lot. No ADA parking signs.

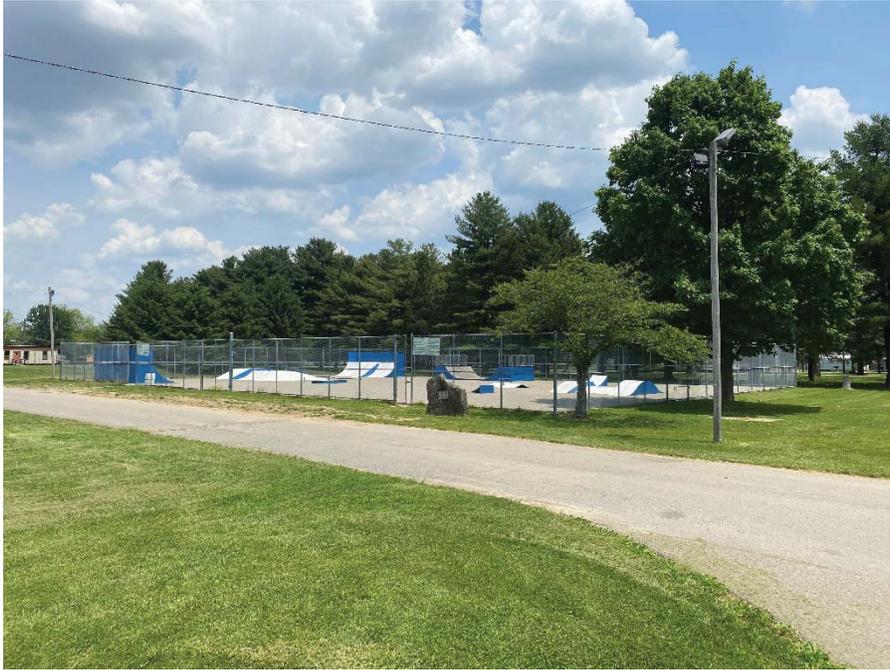
Skate Park Entrance

Skate Park - Parking Lot		
Stall Width	Measured	N/A
	ADA	96" MIN
Aisle Width	Measured	N/A
	ADA	96" MIN
Curb Ramp Width	Measured	N/A
	ADA	48" MIN
Curb Ramp Cross Slope	Measured	N/A
	ADA	2% MAX
Curb Ramp Running Slope	Measured	N/A
	ADA	8.33% MAX
Notes		No ADA parking stalls. No sidewalks to facilities.
